CRASH OF THE POLISH GOVERNMENTAL PLANE PLF 101¹
SMOLENSK, RUSSIA, APRIL 10, 2010

Smolensk Pattern
Threatens International Aviation

MARIA SZONERT BINIENDA, ESQ.

March 2012

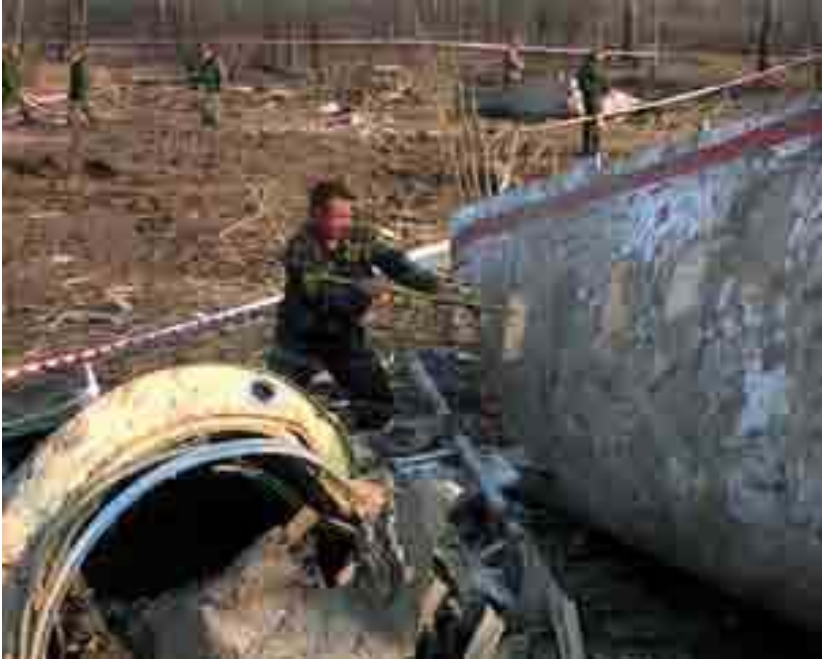
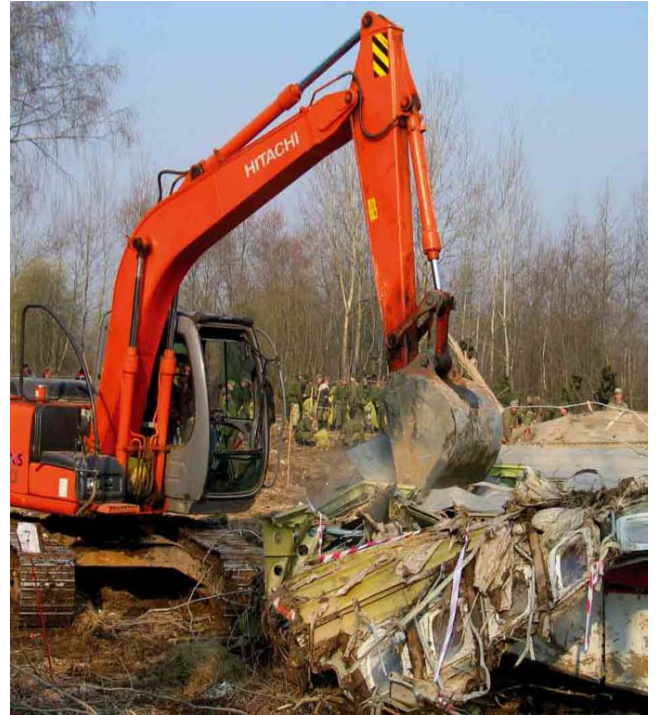
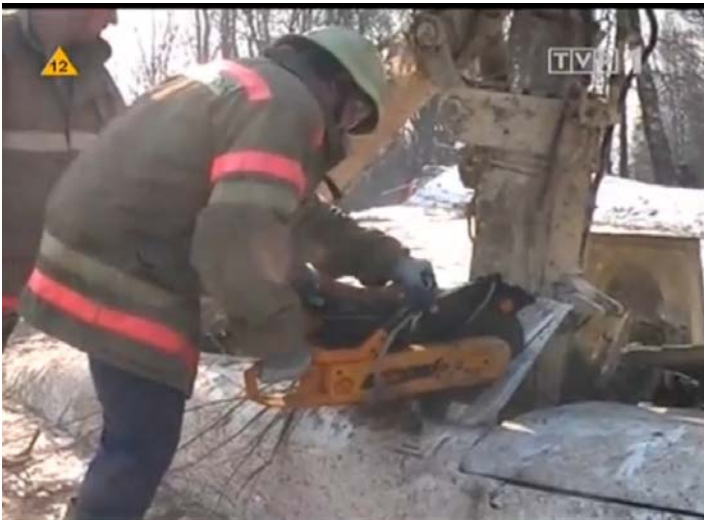
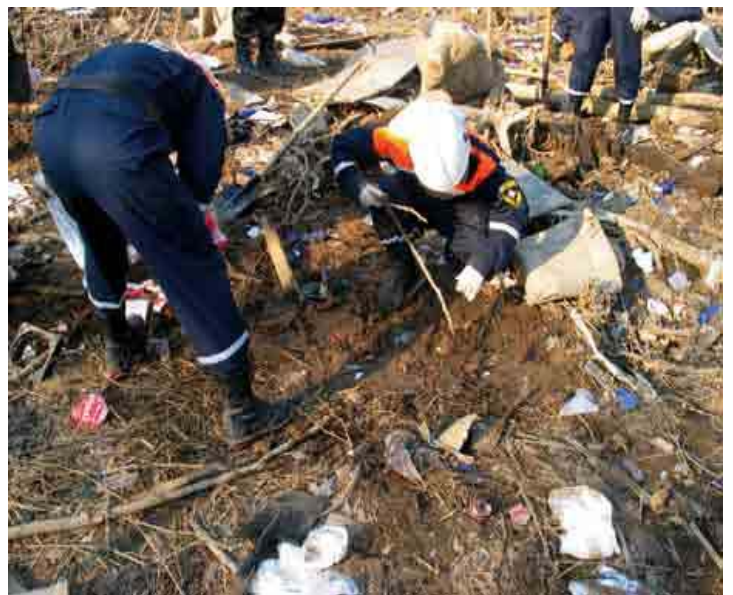
Appendix: Destruction of Evidence
Photos Taken at the Scene of the Smolensk Crash on April 11, 2010⁷⁷

In October 2010, the Polish press published photos showing the process of demolition of the wreckage of the Tu-154M airplane at the Smolensk 'Severny' Airport that took place the next day after the crash. Video footage of the Russian workers destroying the wreckage of the Tu-154M airplane on April 11, 2010 is shown in a documentary "Misja specjalna" by A. Gargas.¹⁰
