Remarks
Of the Republic of Poland
as:
the state of registration and operator

on the draft Final Report
regarding
the investigation into the accident of the Tu-154M tail number 101 aircraft
which occurred on 10 April 2010
drafted by
the Interstate Aviation Committee (IAC)

Warsaw, 19 December 2010

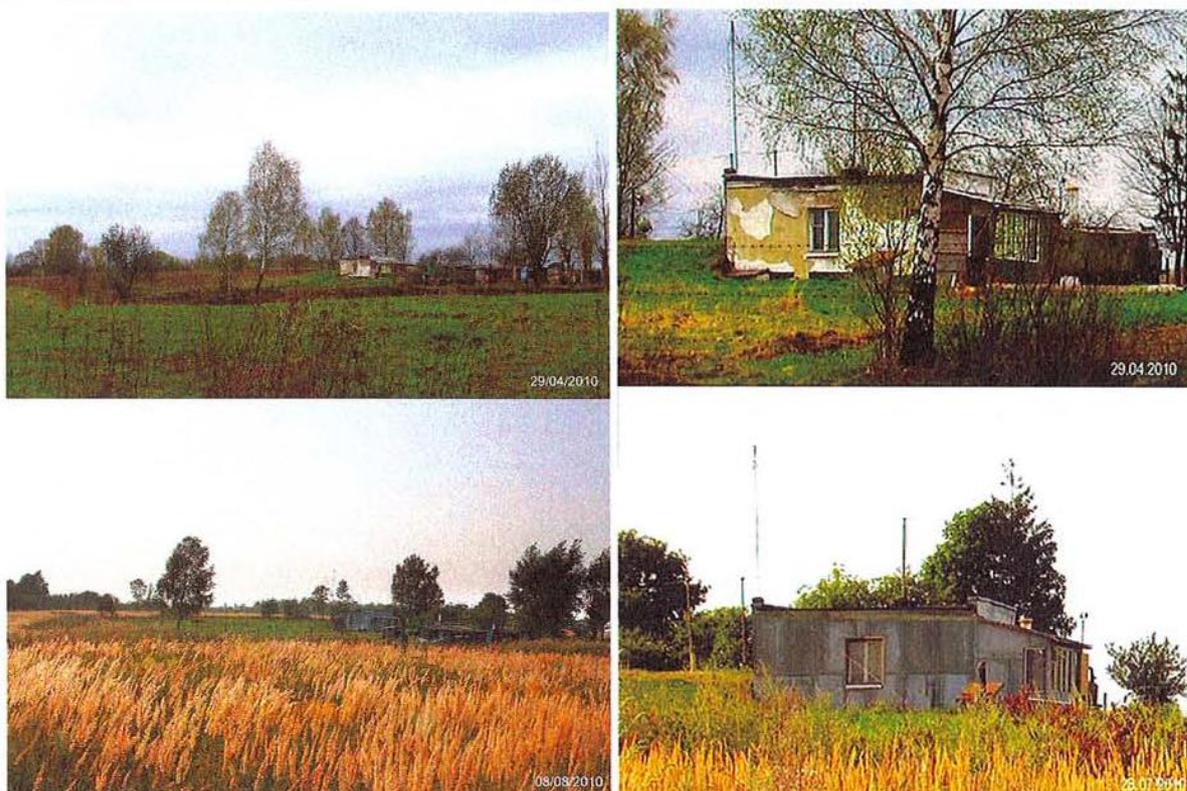
In accordance with the minutes of interrogation, dated 3 May 2010, of Yak-40 crew commander, which landed at the Smolensk “Severny” aerodrome on 10 April 2010 (Before the arrival of the Tu-154M aircraft), the middle NDB did not work reliably. Indications varied within $\pm 10^\circ$. The probable cause of unstable performance of the NDB were trees growing in the beacon antenna field, by far exceeding the height of the antenna mast, the presence of an overhead power line and the ravine in the immediate vicinity of the NDB. These factors may have affected the NDB antenna pattern.

Differences in the state of tree - the area of the NDB, around 1000 m from the threshold of runway 26

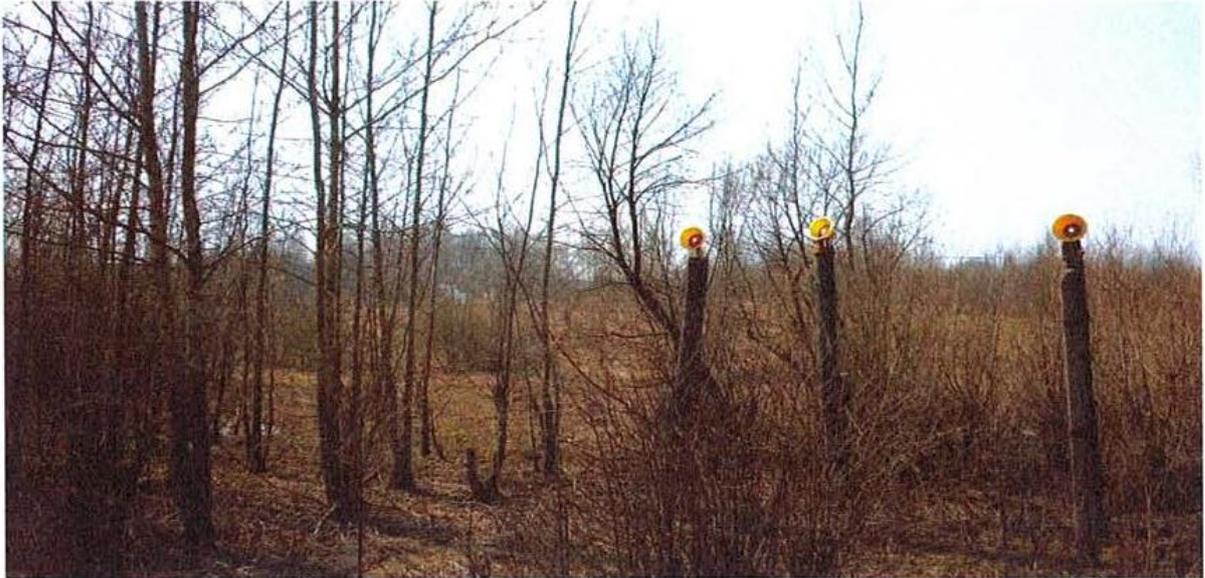
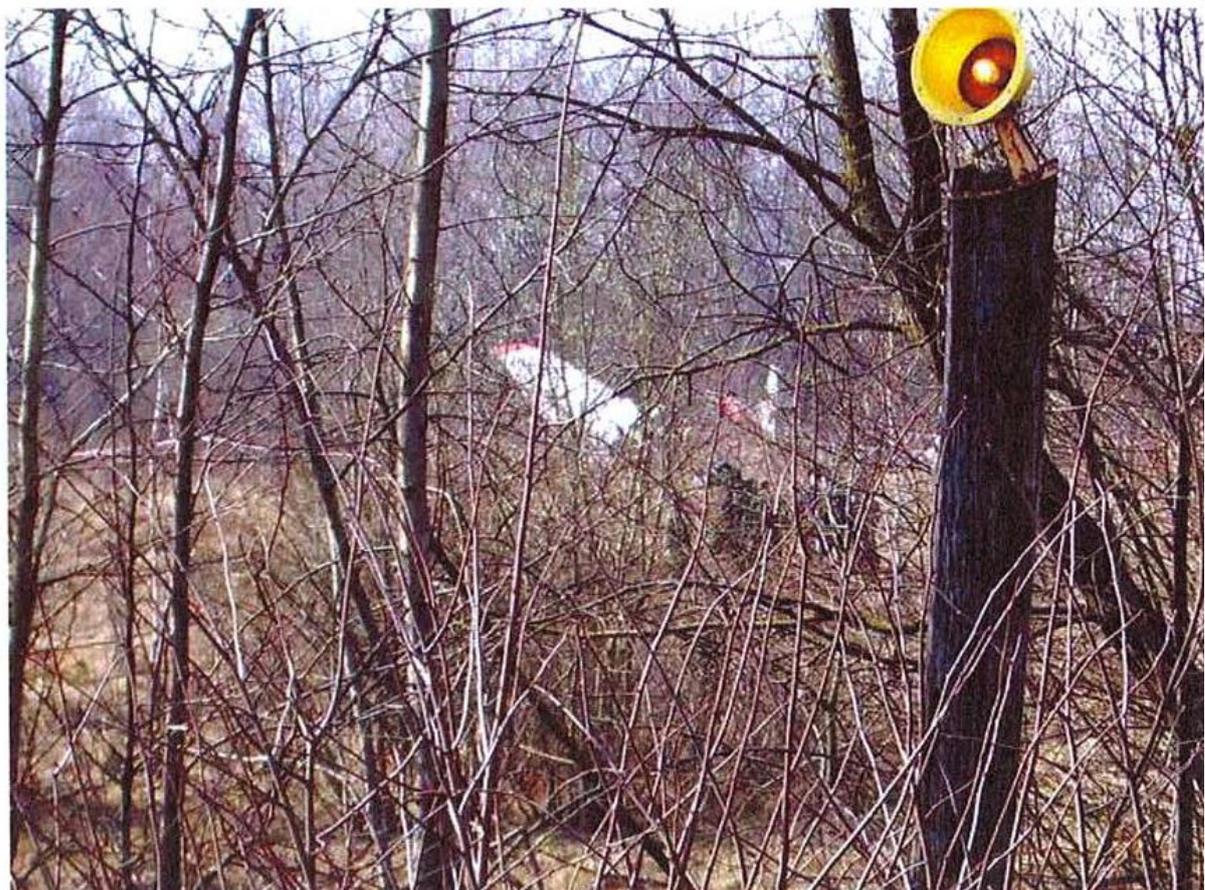
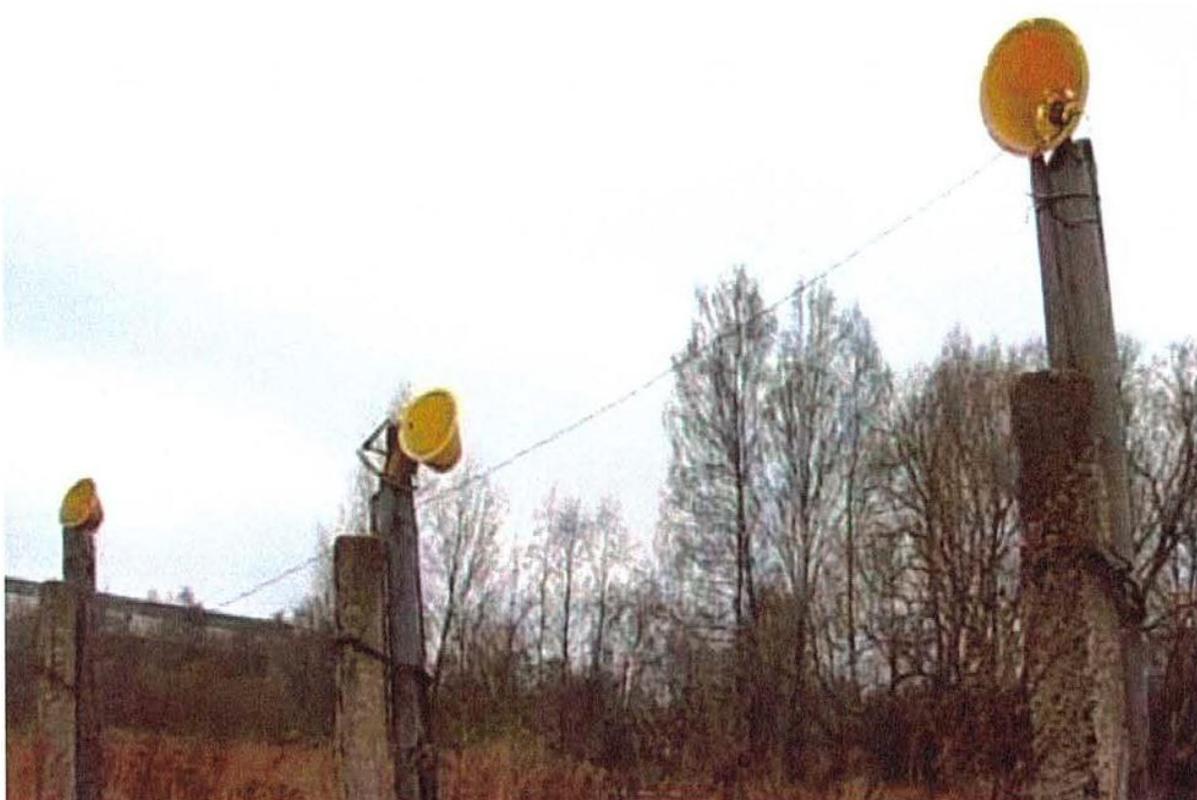
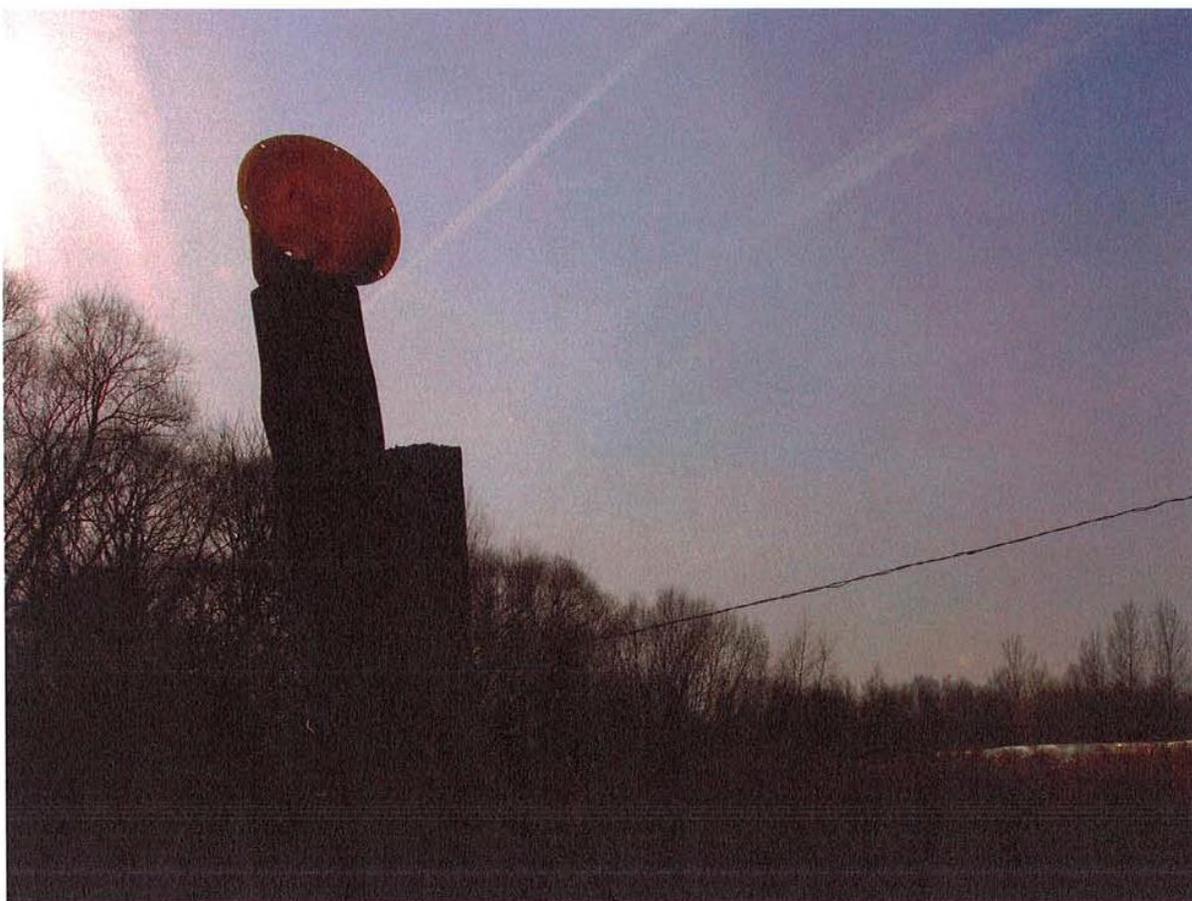
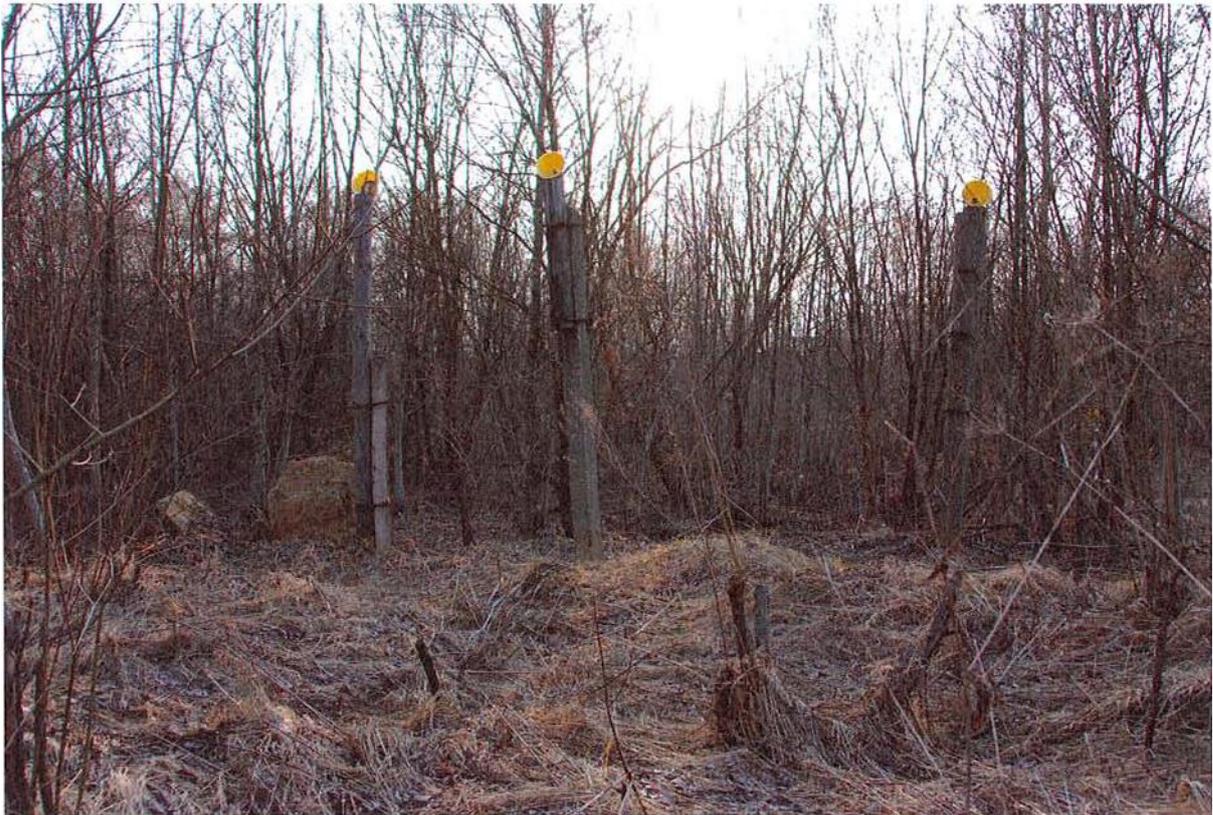
The appearance of the “LUCH-2MU” lighting equipment at the Smolensk “Severny” aerodrome on 10 April 2010

The photographic documentation made on 10 April 2010 shows that the approach and horizon lights at the Smolensk “Severny” aerodrome did not belong to the LUCH-2MU device as described in the Report in point. 1.8. “Landing navigational equipment and UWD”, item “aerodrome lighting equipment”.

The above photographic documentation shows, that the lighting elements of the lighting system of the Smolensk “Severny” aerodrome originated from an unspecified device, did not have mirrors and focusing lenses, and did not possess a vertical and horizontal plane lighting angle adjustment function.

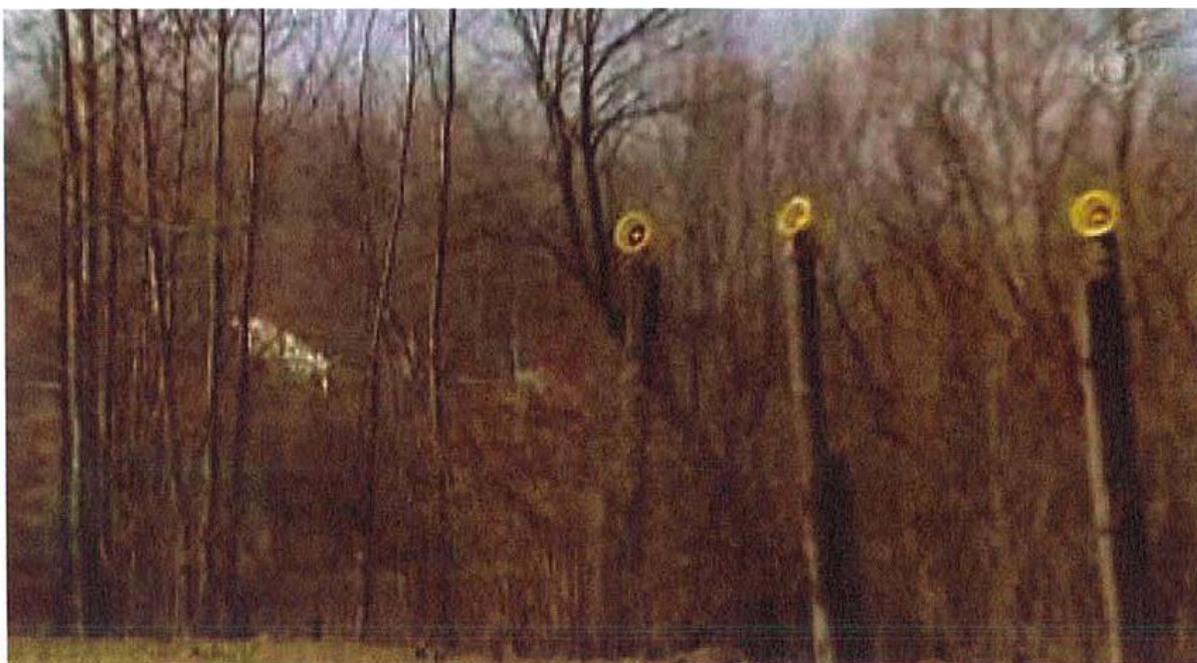
Moreover, information contained in point 1.16.7 “Assessment of the lighting system visibility” which pertains to the statement, ‘that the crew could not even make visual contact with the first (900 metres from the DS)’ row of approach lights may be true, as the elements of the lighting system laid out at the Smolensk “Severny” aerodrome were not of headlight type, and their photometric characteristics were far from the required standards (pictured below).

Note the text in figure 42: is $\Delta L = 755$ m and should be $\Delta L = 725$ m.

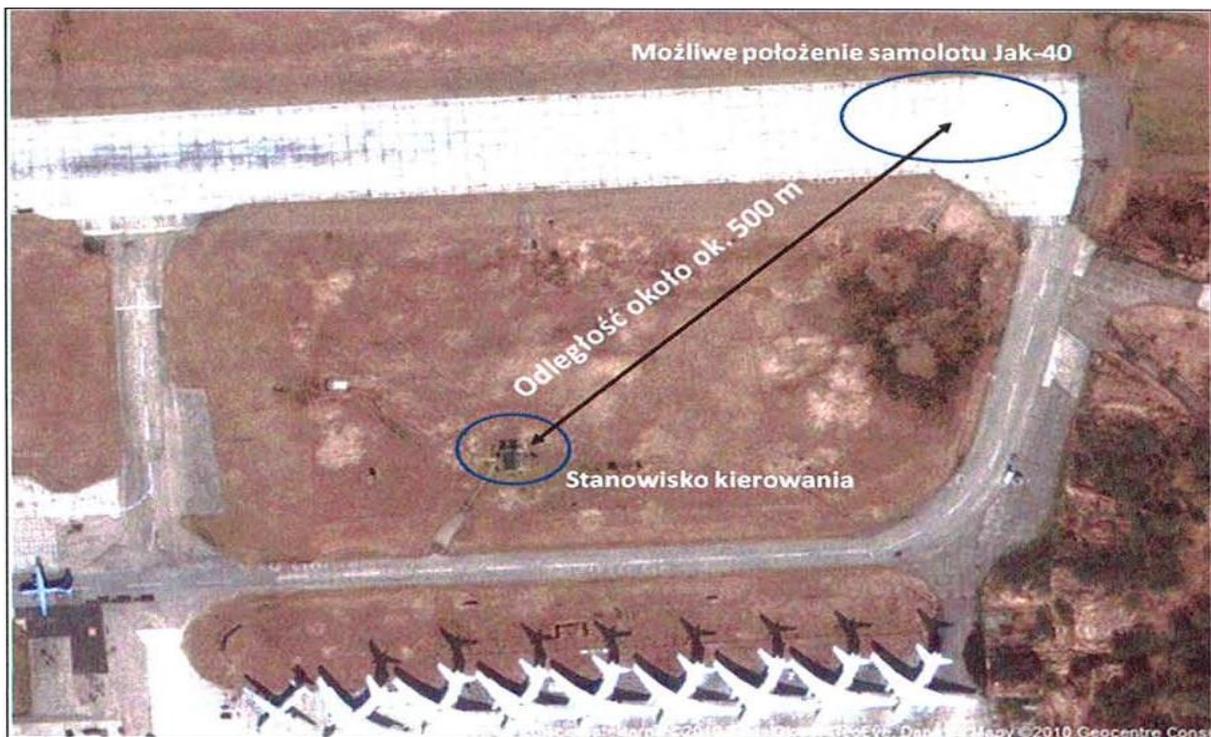
The CATC saw the Yak-40 plane just above the DS 26 threshold. An analysis of the distance between the position of individual objects (see picture below) shows that the actual visibility during Yak-40 aircraft’s landing was no greater than 500 metres.

Possible location of the Jak-40 aeroplane

Distance approx. 500 m

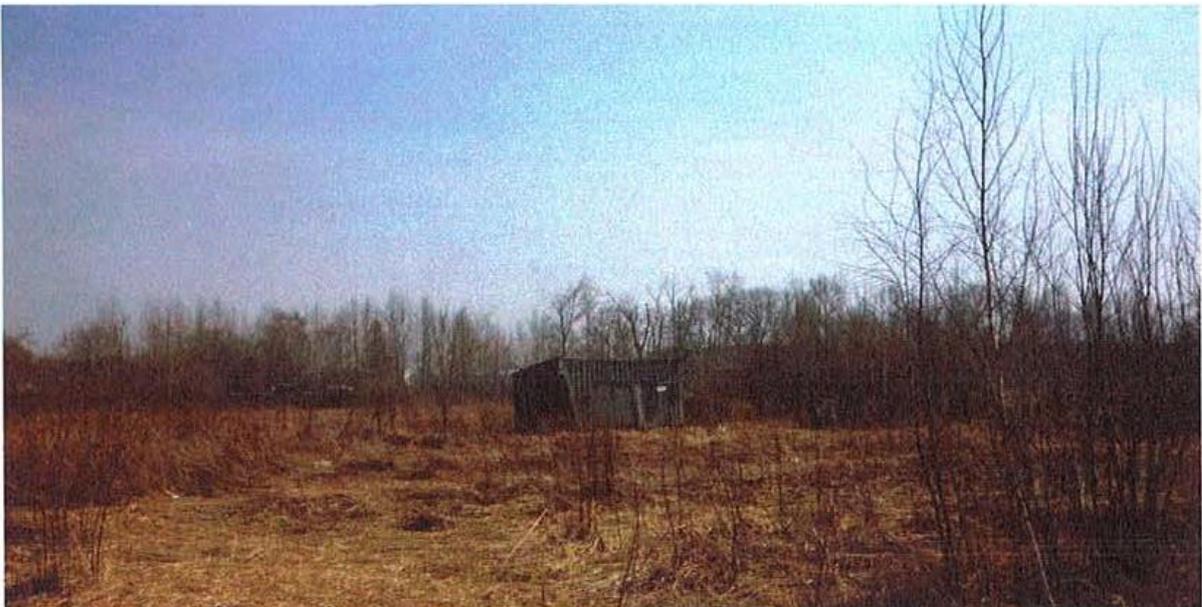
In both options, it was found that the area situated at a 300 m to 850-900 m distance from the DS 26 threshold, within the approach limiting surface from the 259° direction, was overgrown with plenty of shrubs and featured clusters (groups) of trees of a height of the order of 20 - 25 m above ground level, which exceeded (sometimes significantly, by approximately up to 15 m) the maximum admissible height of objects set by the above stated limiting surface, particularly in the area of the motorway intersecting the approach (400 m -700 m from the DS 26 threshold).

Trees and shrubs app. 500 m from the DS 26 threshold (view toward 259° approach)

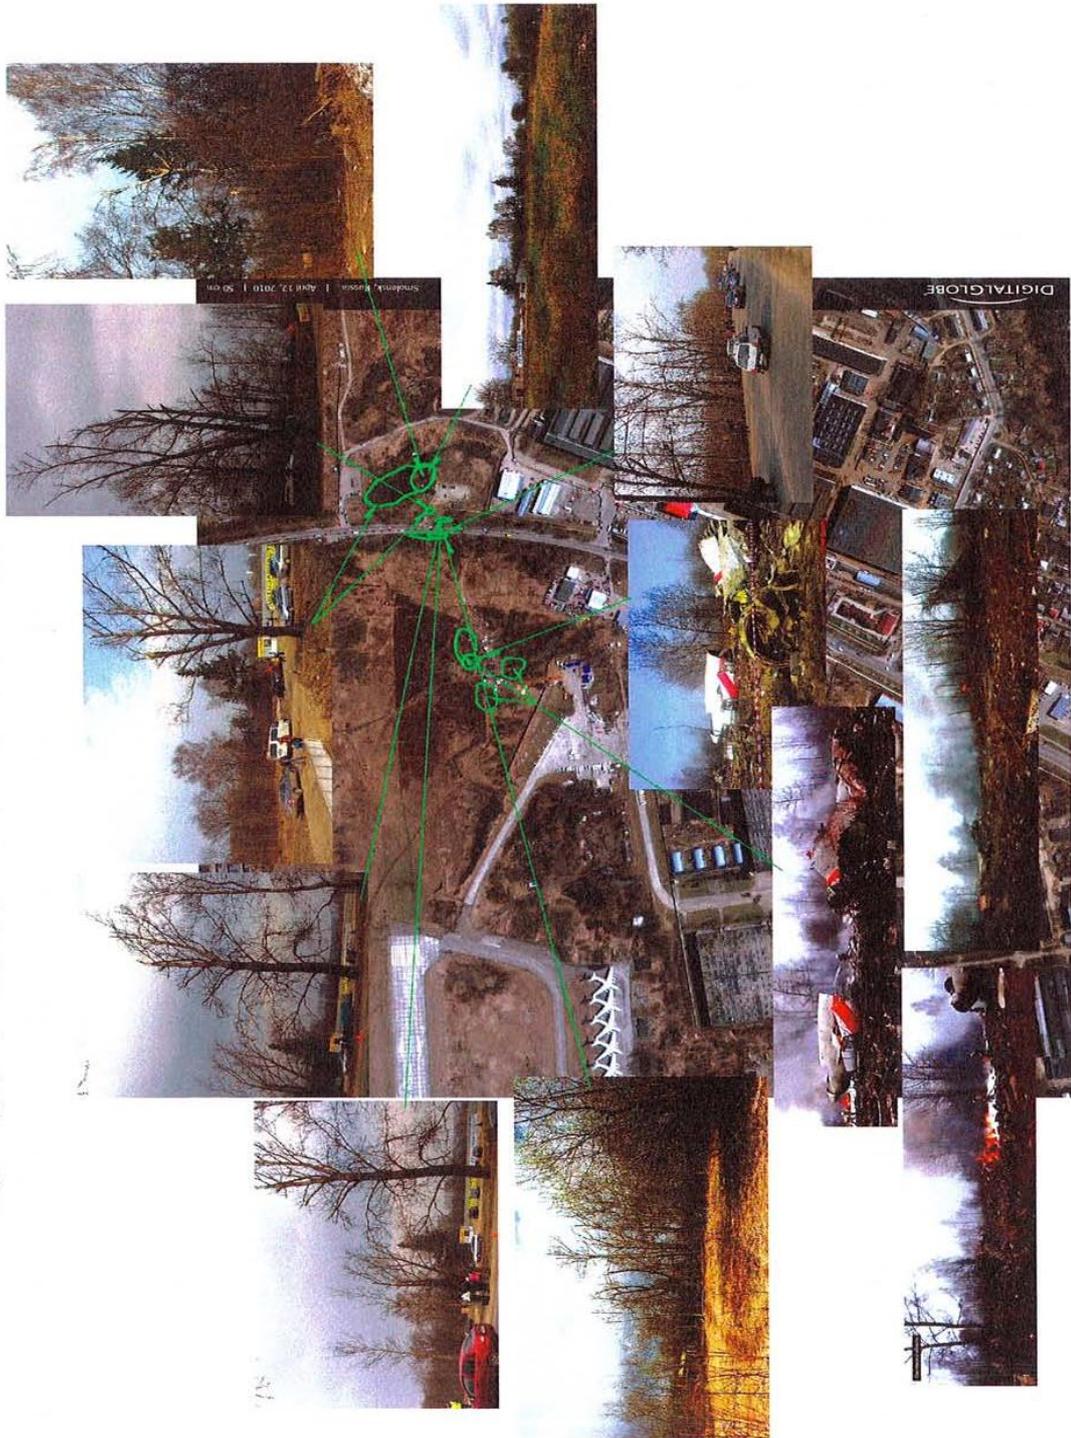
Distribution of some clusters of trees in the approach surface area

This is inconsistent with the Polish, Russian and ICAO (Annex 14) regulations. These clusters of trees in question constituted a real threat to aircraft approaching for landing on the DS 26, especially in the difficult weather conditions that prevailed on 10 April 2010. Moreover, the trees and shrubs growing in the area before the DS 26 threshold obscured lights from the lighting system for the crews and limited SKL personnel's already obstructed visibility (due to fog) from SKL toward the 259° approach. In these circumstances, one cannot claim the aerodrome was fully operational and ready to accept aircraft, particularly those of HEAD status. It should be noted, that *"The act of technical review of the Smolensk "Severny" aerodrome to accept special flights"* dated on 5.04.2010, merely states that, quote: *"... at a distance of 1 to 4 km from the runway threshold, there are no obstacles measuring over 10 m in height relative to the runway threshold and from 4 km to the end of the approach strip, measuring 50 m relative to the runway threshold"*. No information is given about any possible obstacles situated at a distance of up to 1 km from the DS 26 threshold, i.e. in the area where representatives of the Polish side had found clusters of tall trees. The Polish side's assessment of the forest stand having exceeded permissible height levels along the DS 26 approach is confirmed by the mass logging of trees and shrubs in that area, which took place after the accident, as had been established based on the available photo documentation (picture below).

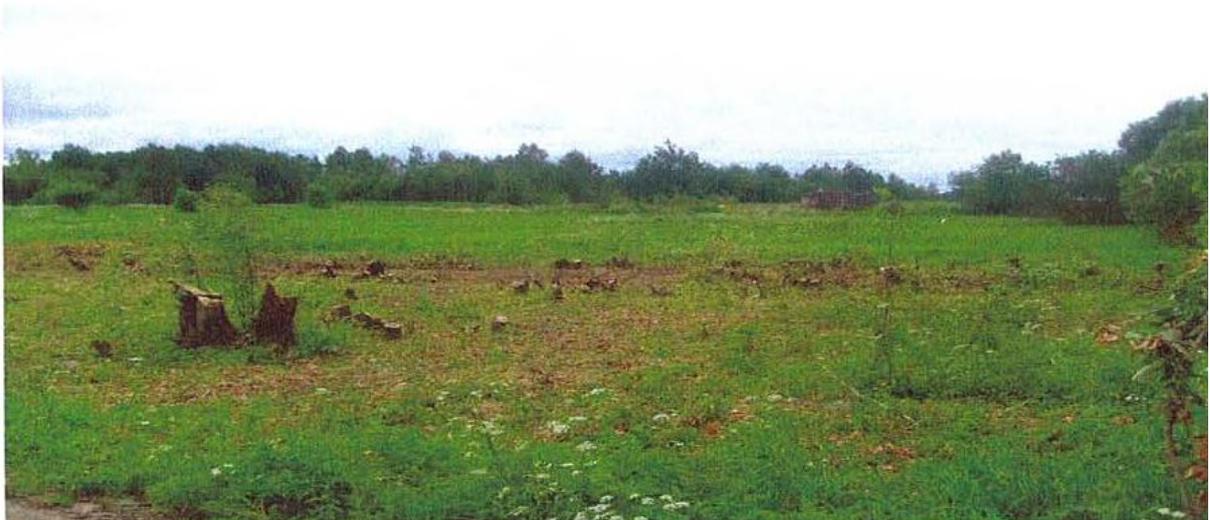
Logged trees and shrubs – app. 600 m from the DS 26 threshold (view toward the DS).

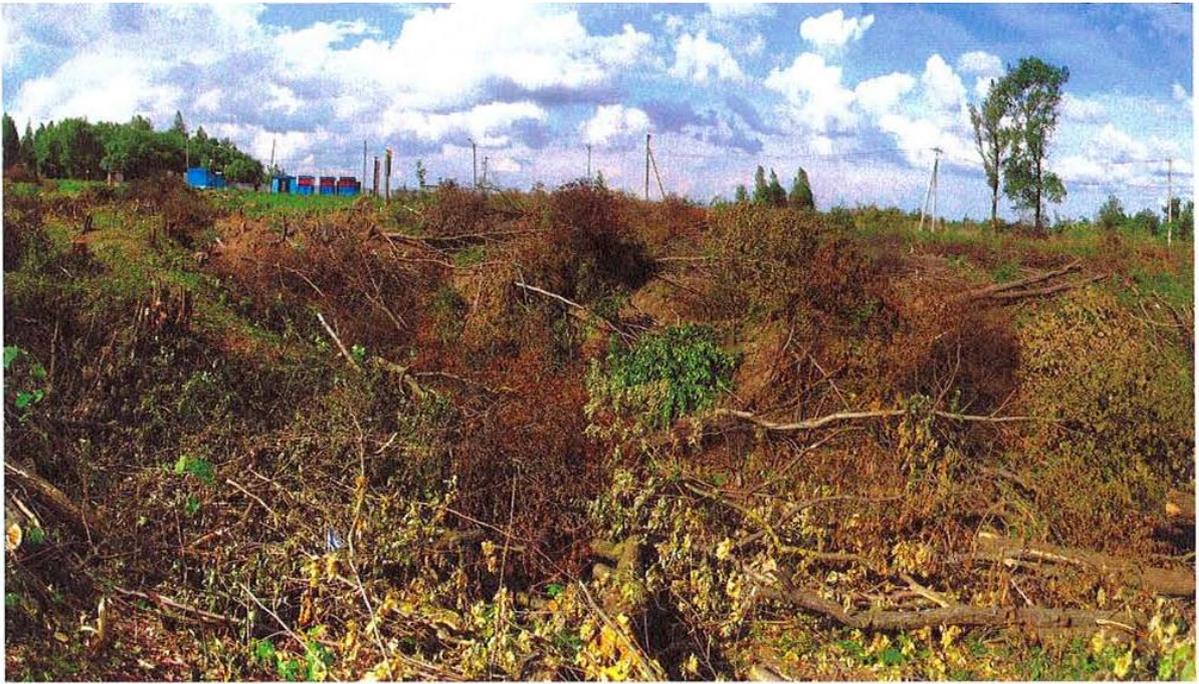
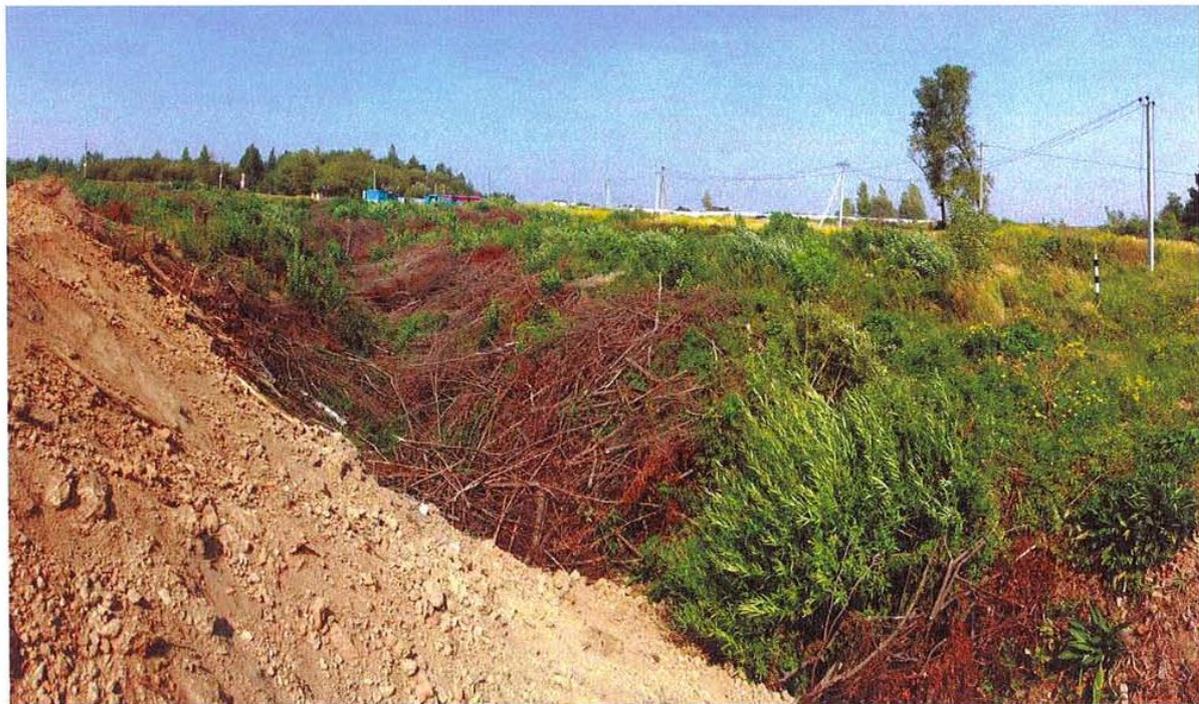
Logged trees and shrubs at the approach axis, at app. 700 m distance from the DS 26 threshold.

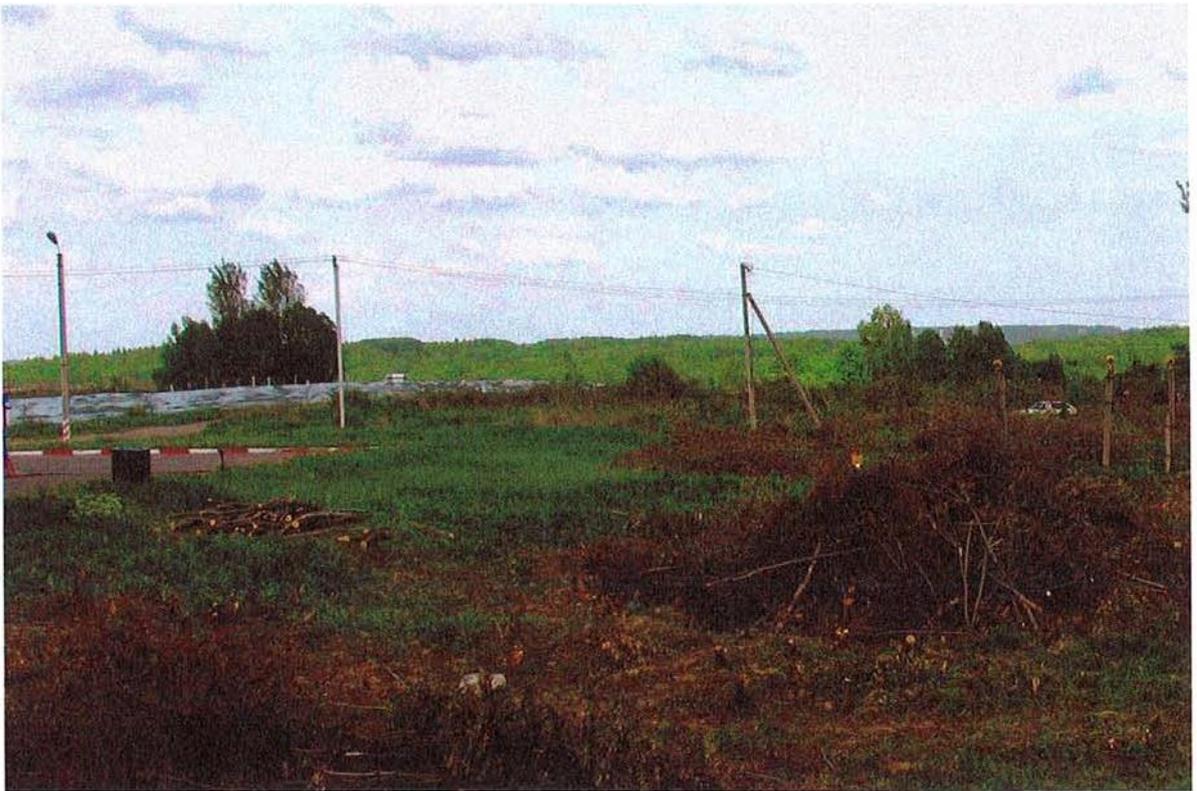
Logged trees and shrubs at the approach axis, at app. 700 m distance from the DS 26 threshold.

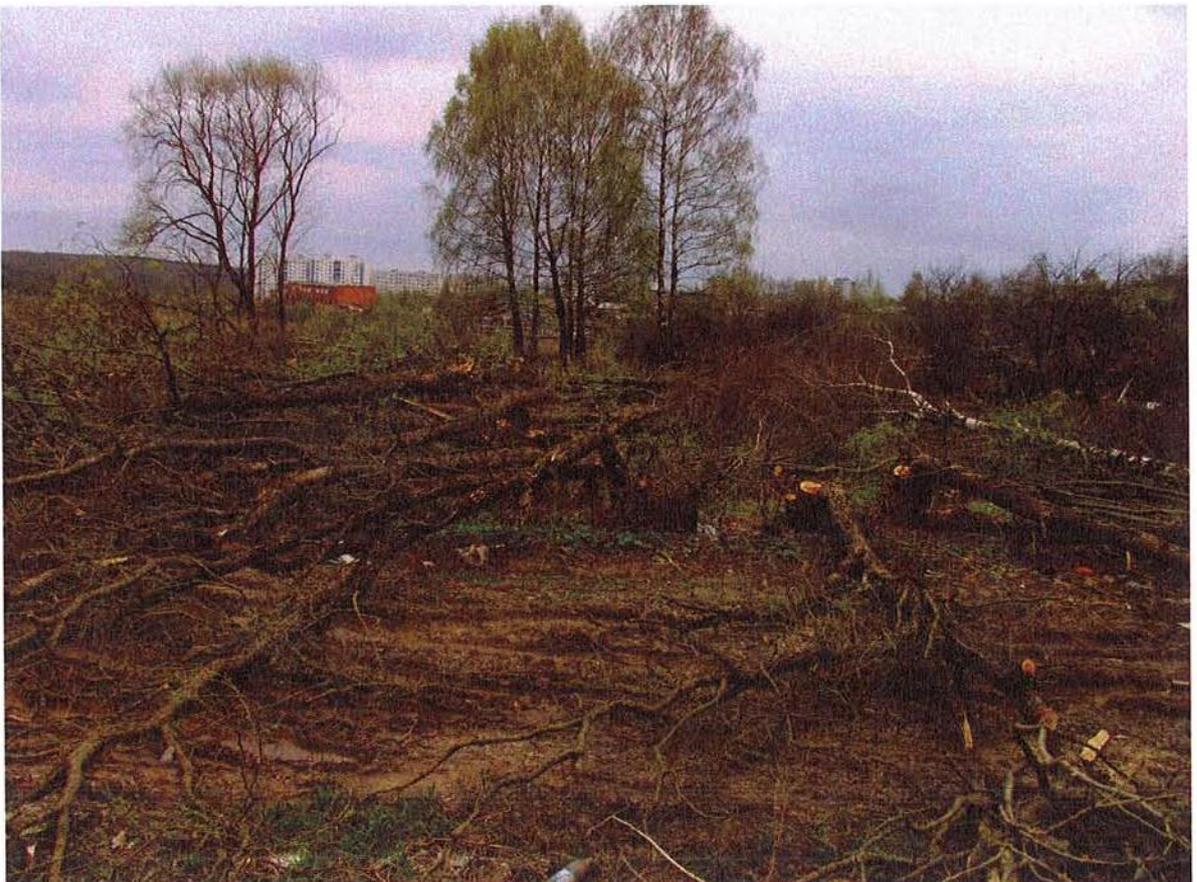
Logged trees in the BRL area app. 900 m from the DS 26 threshold

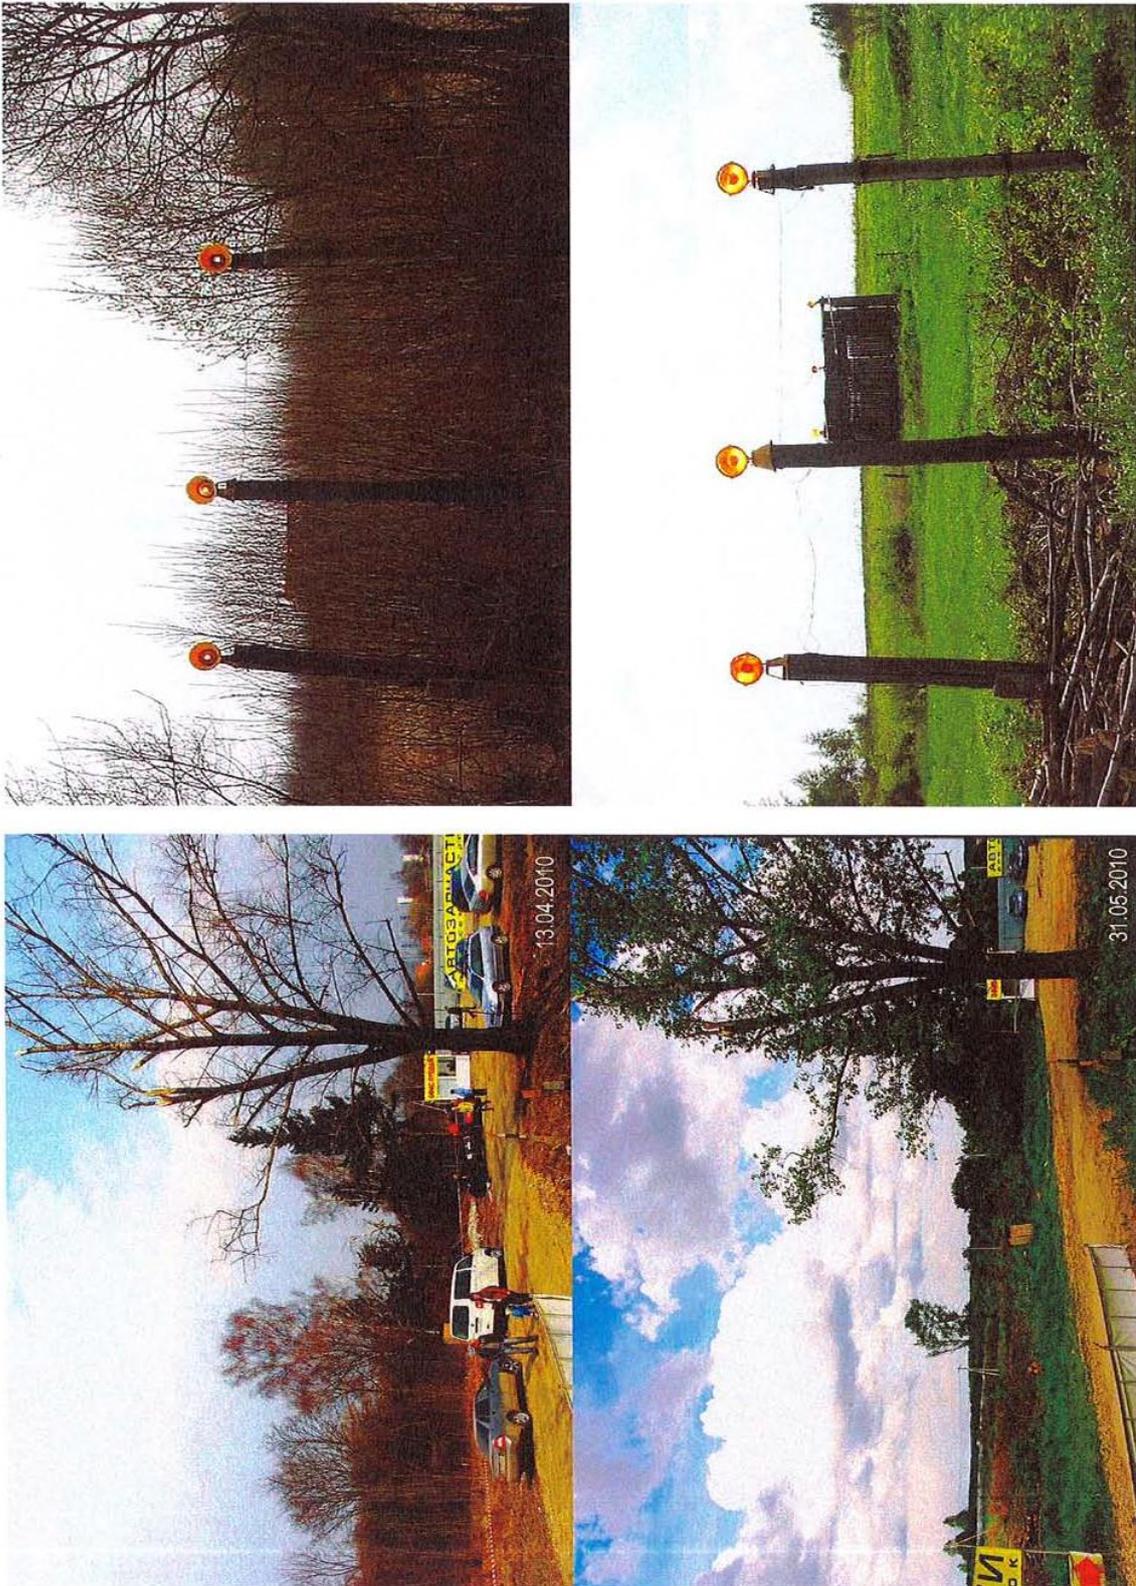
Differences in condition of the forest stand - area of the approach axis next to the motorway app. 600-650 m from the DS 26 threshold.

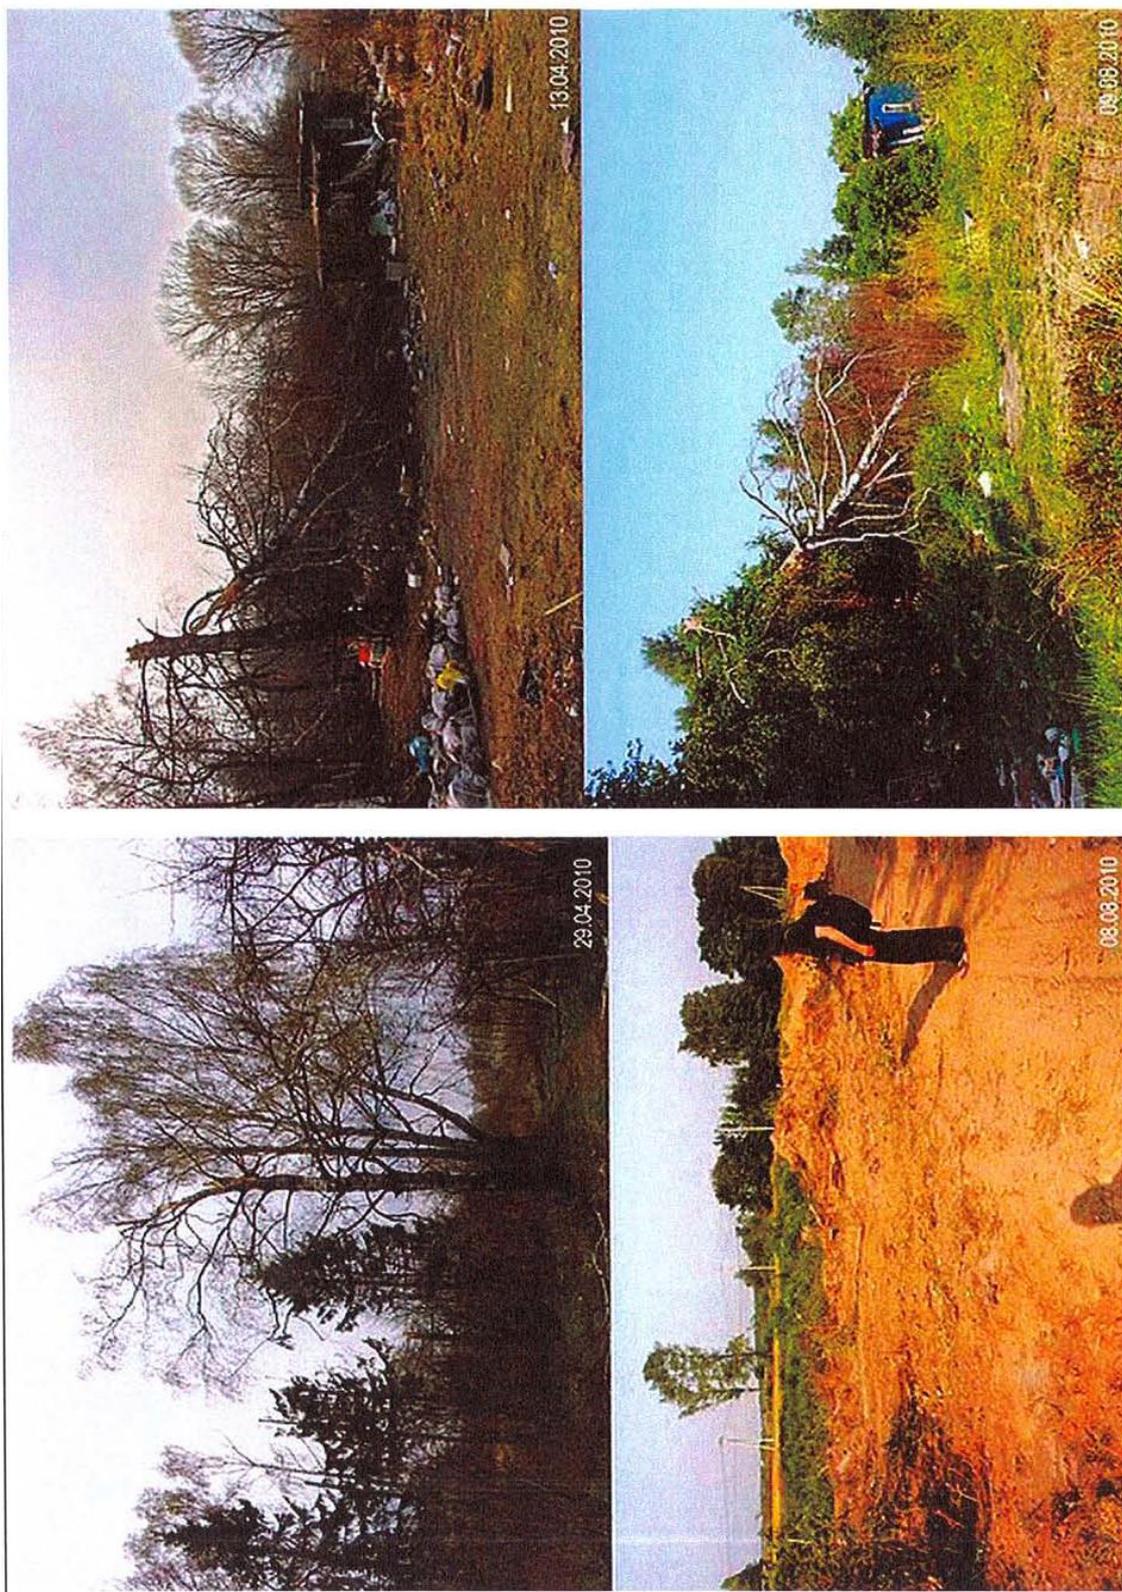
Differences in the condition of the forest stand – area at an approximately 700-800 m distance from the DS 26 threshold.

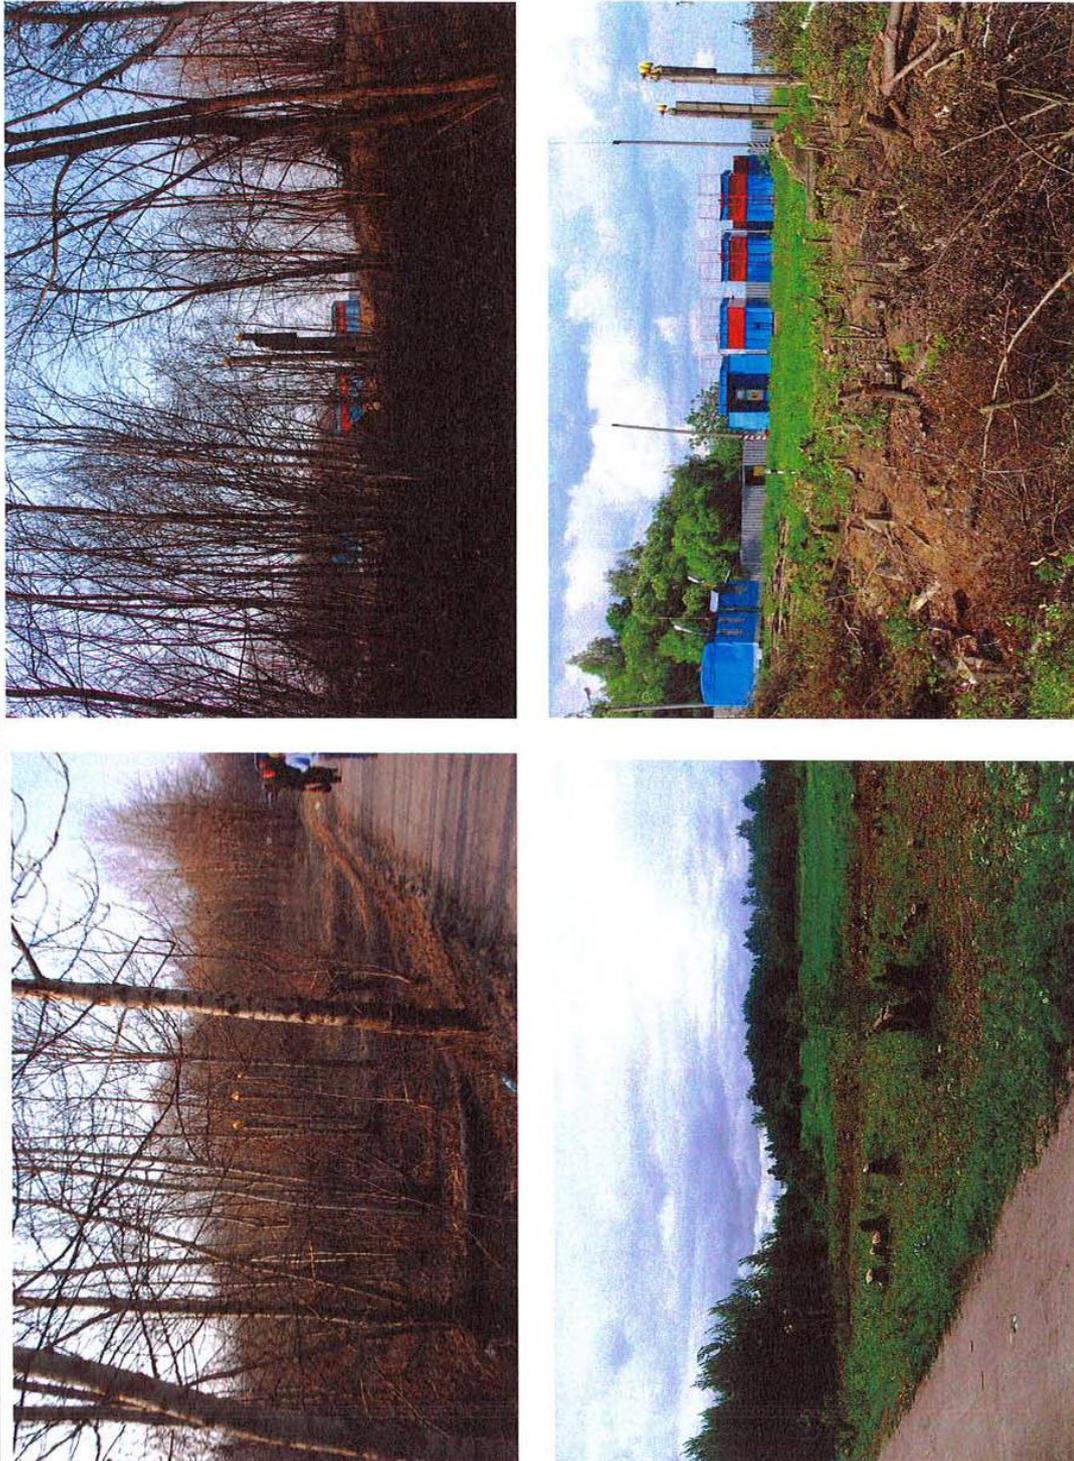
Differences in the condition of the forest stand – area of the approach axis app. 600 m and 700 m from the DS threshold.

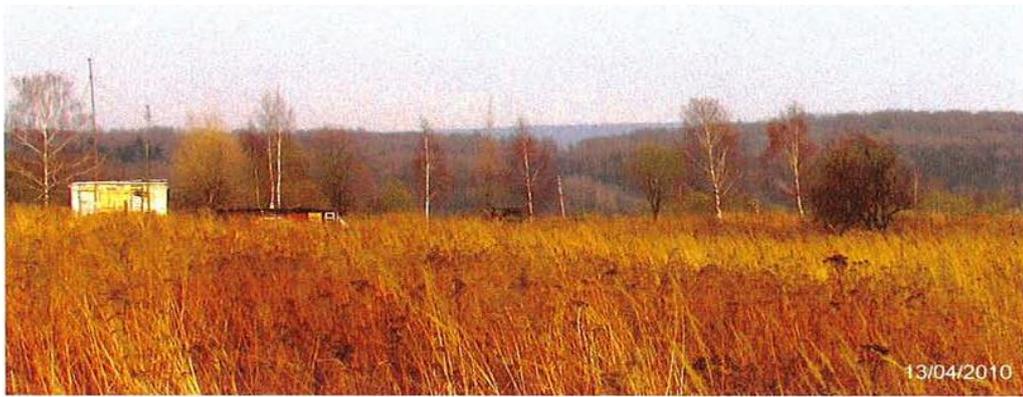
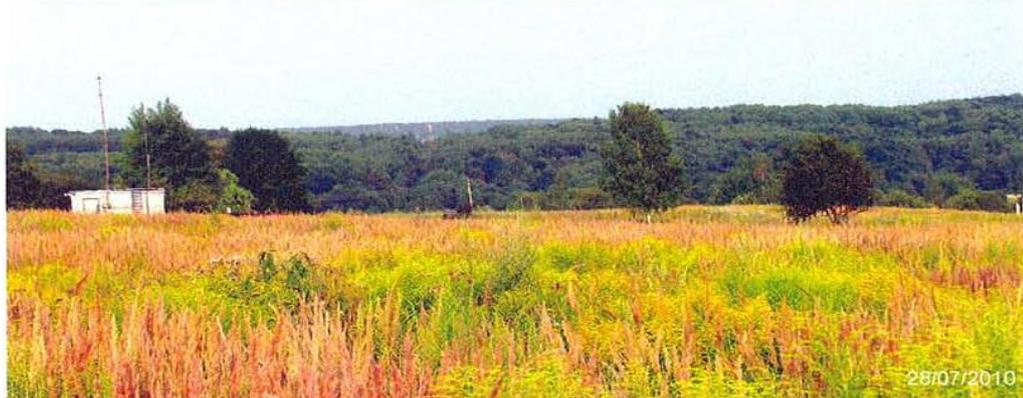
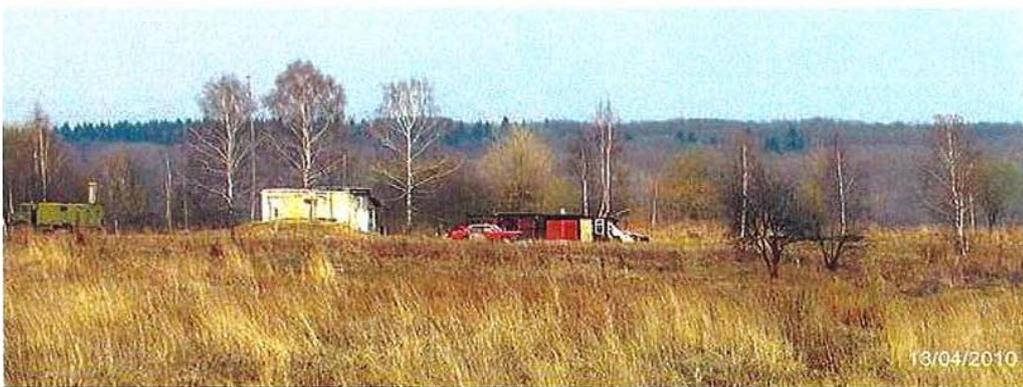
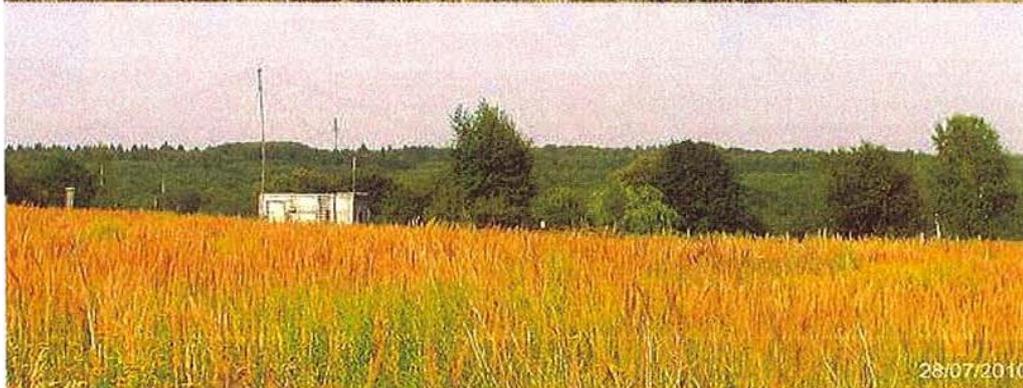
Differences in the condition of the forest stand - BRL area app. 1000 m from the DS 26 threshold.
