Remarks
Of the Republic of Poland
as:
the state of registration and operator

on the draft Final Report
regarding
the investigation into the accident of the Tu-154M tail number 101 aircraft
which occurred on 10 April 2010
drafted by
the Interstate Aviation Committee (IAC)

Warsaw, 19 December 2010

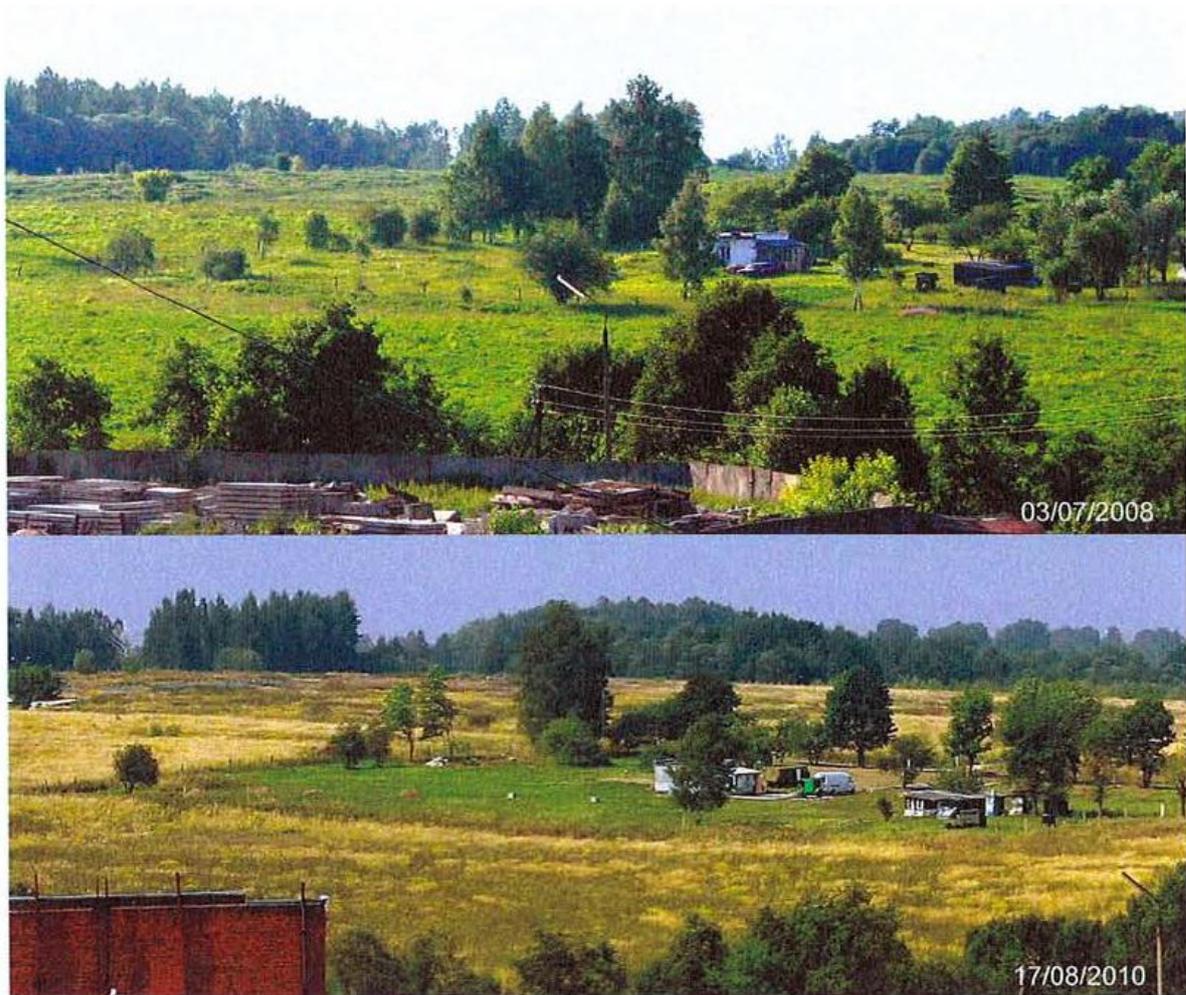
Differences in the condition of the forest stand - BRL area app. 1000 m from the DS 26 threshold.
