CRASH OF THE POLISH GOVERNMENTAL PLANE PLF 101¹
SMOLENSK, RUSSIA, APRIL 10, 2010

Smolensk Pattern
Threatens International Aviation

MARIA SZONERT BINIENDA, ESQ.

March 2012

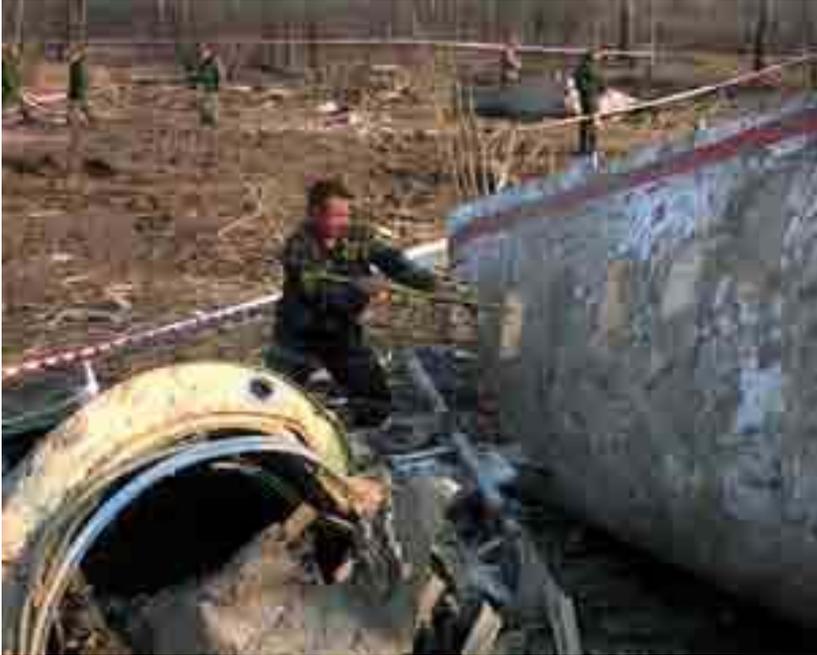
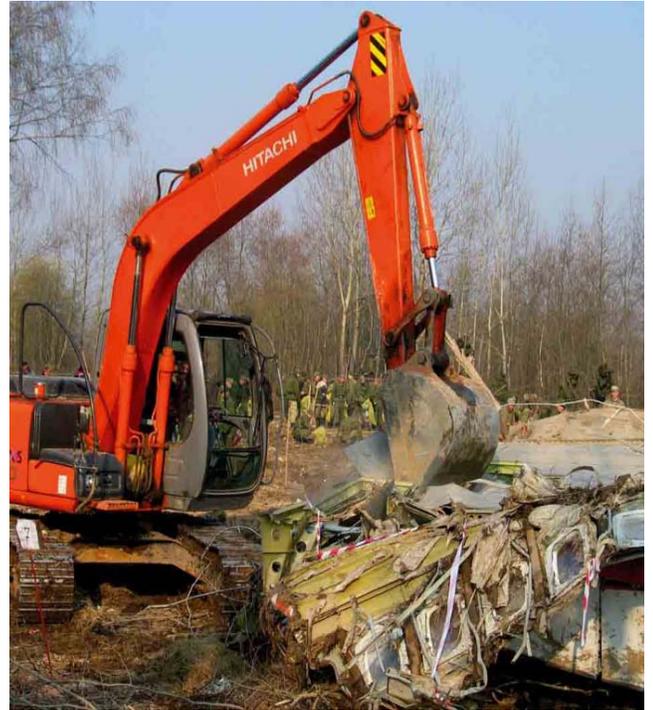
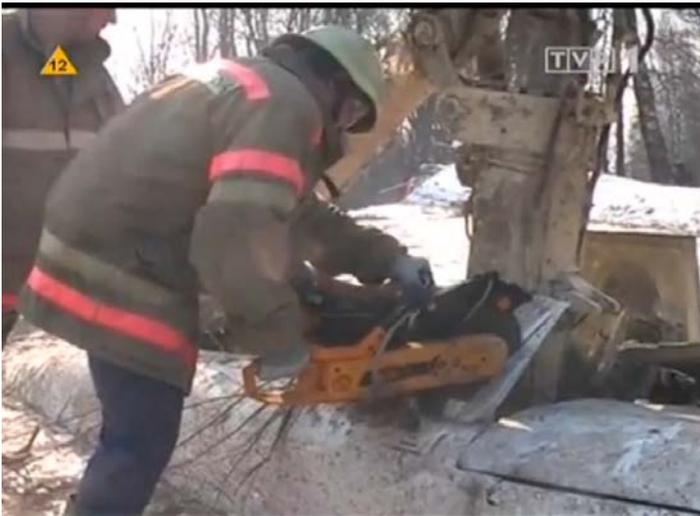
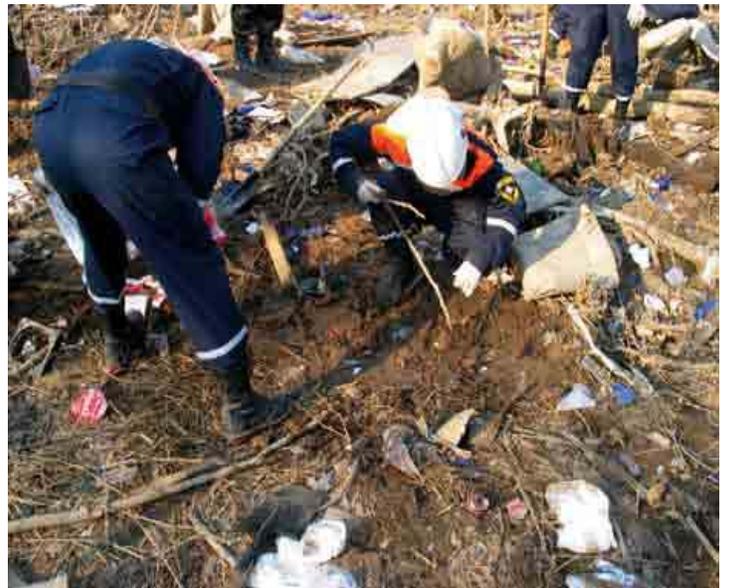
Appendix: Destruction of Evidence
Photos Taken at the Scene of the Smolensk Crash on April 11, 2010⁸⁶

The crash site was not properly secured. Valuable personal belongings of the victims were stolen. In six days, the crash site was transferred to the Administration of Smolensk for "sanitary disposal."²⁰ The area was cleaned up and re-graded; trees were cut down. Many parts of the aircraft went missing.
