MAK and KBWL LP Reports Data Analysis

Kazimierz Nowaczyk, Ph.D.
Assistant Professor
University of Maryland

MAK – Interstate Aviation Committee
KBWL LP - Polish Air Incident Investigation Committee

SOME TECHNICAL AND STRUCTURAL ASPECTS
OF THE SMOLENSK PLANE CRASH

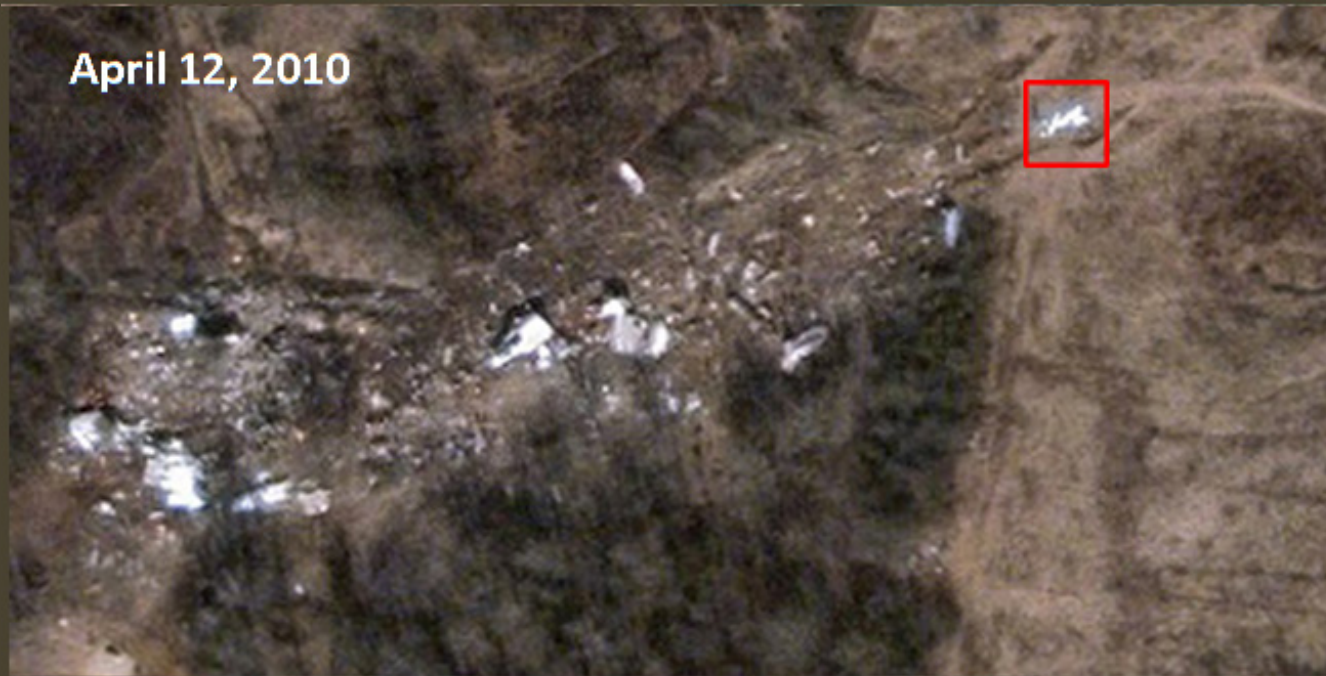
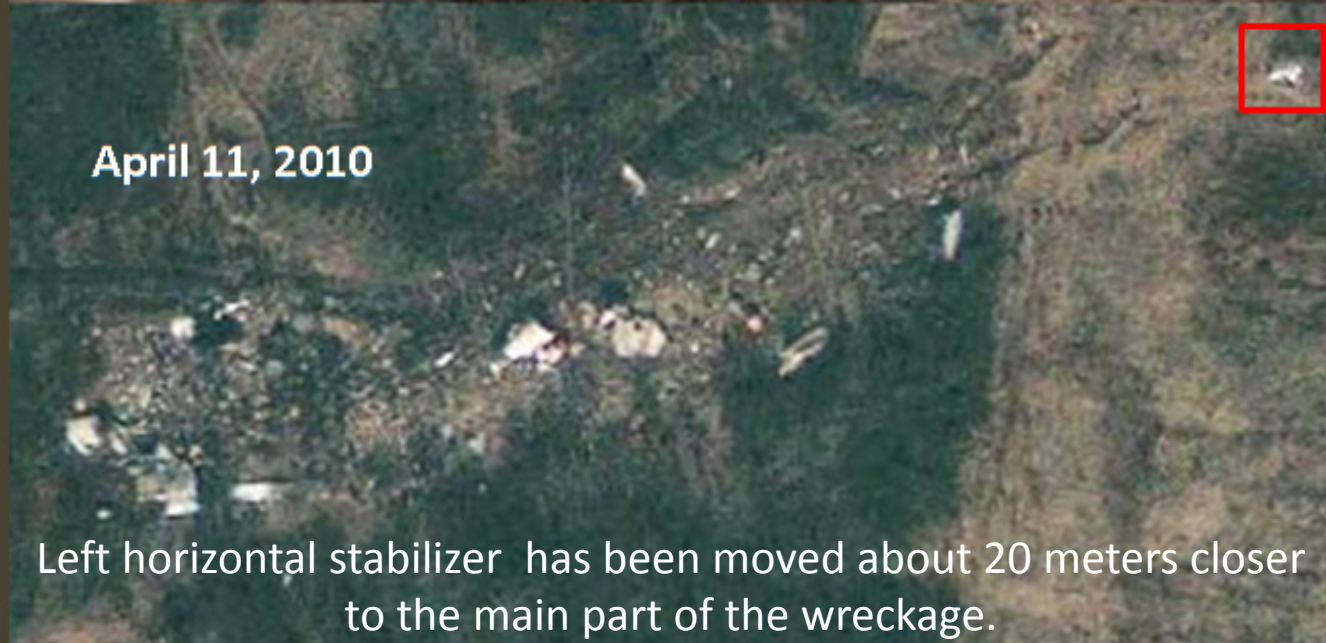
The plane's left horizontal stabilizer position on satellite pictures

Left horizontal stabilizer has been moved about 20 meters closer to the main part of the wreckage.

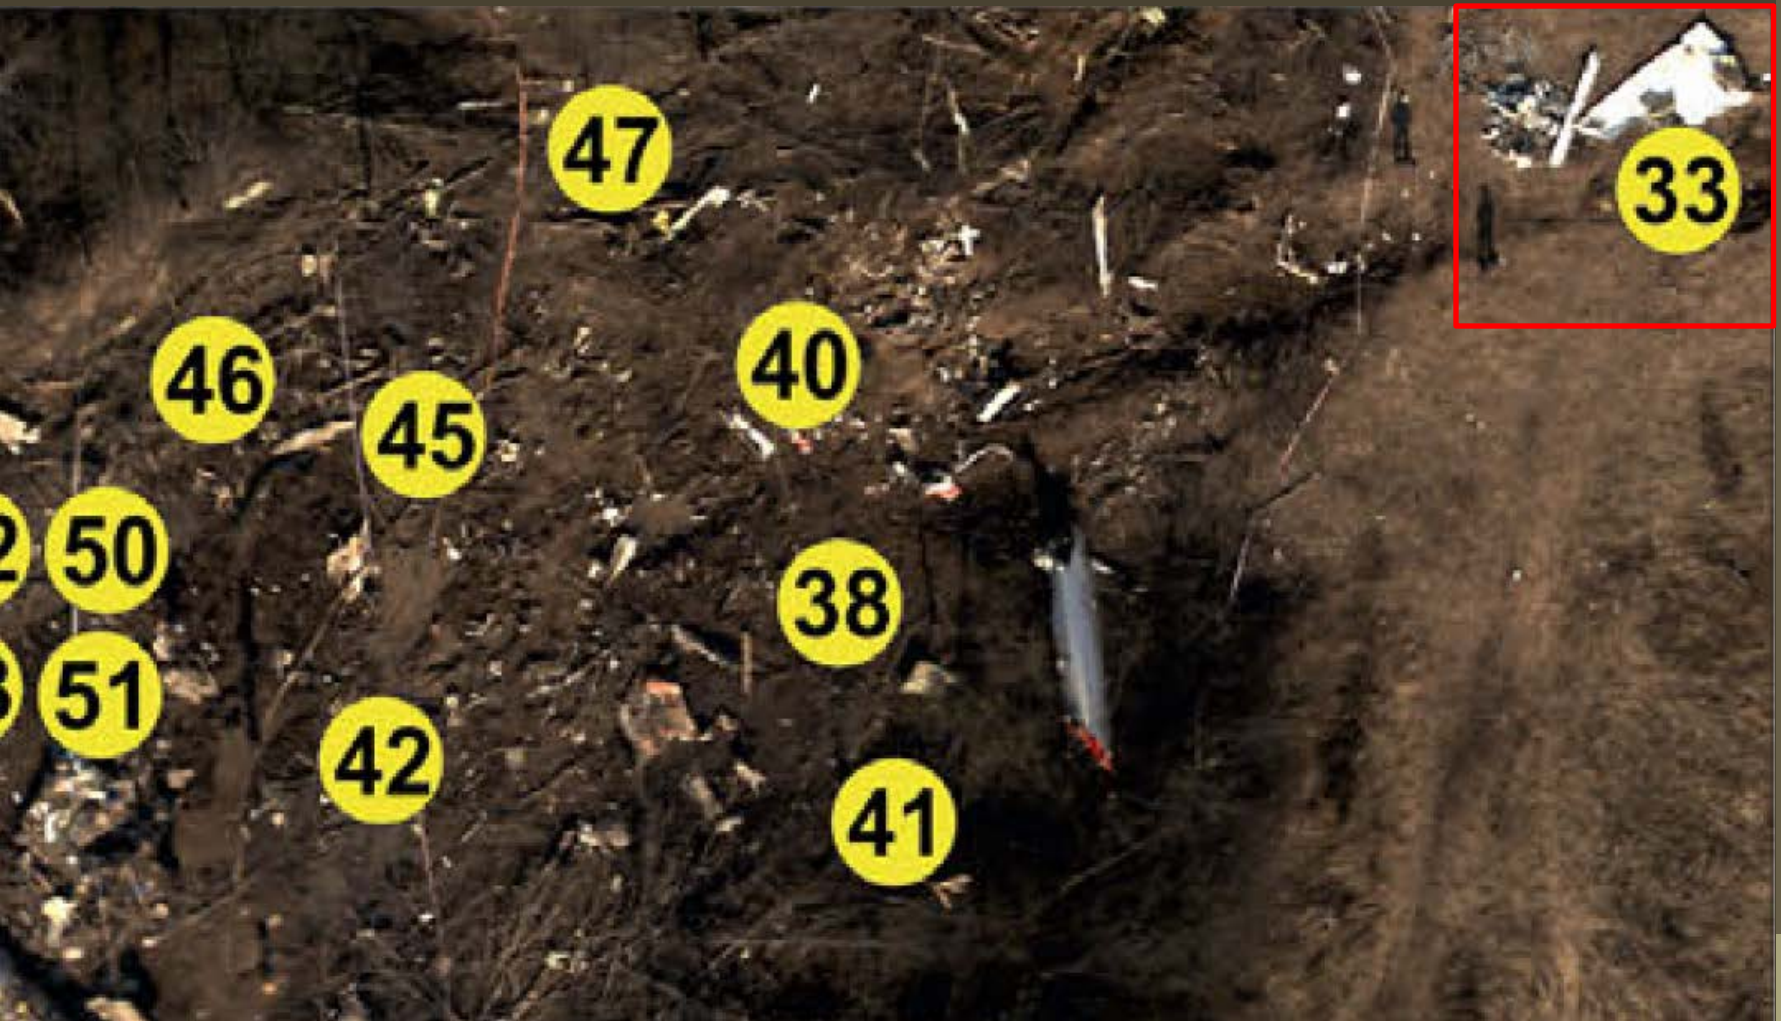
The plane's left horizontal stabilizer position (33) in MAK Report identical to position on satellite picture from April 12, 2010

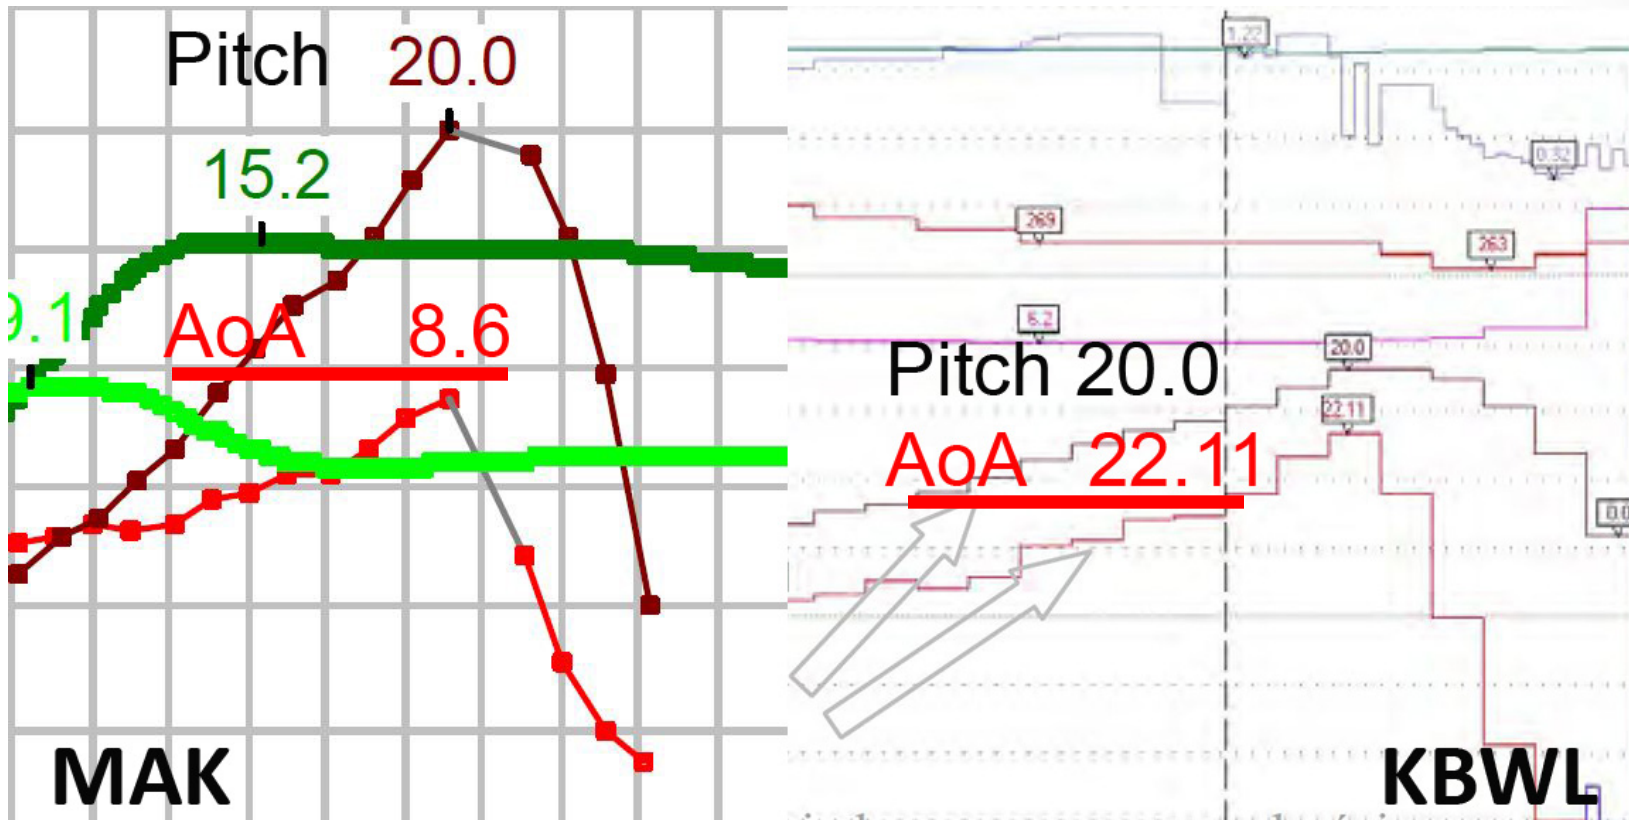
Angle of Attack

The angle-of-attack values are taken from a Russian and a Polish recorder, respectively. Both devices are merely data recorders and not measurement devices

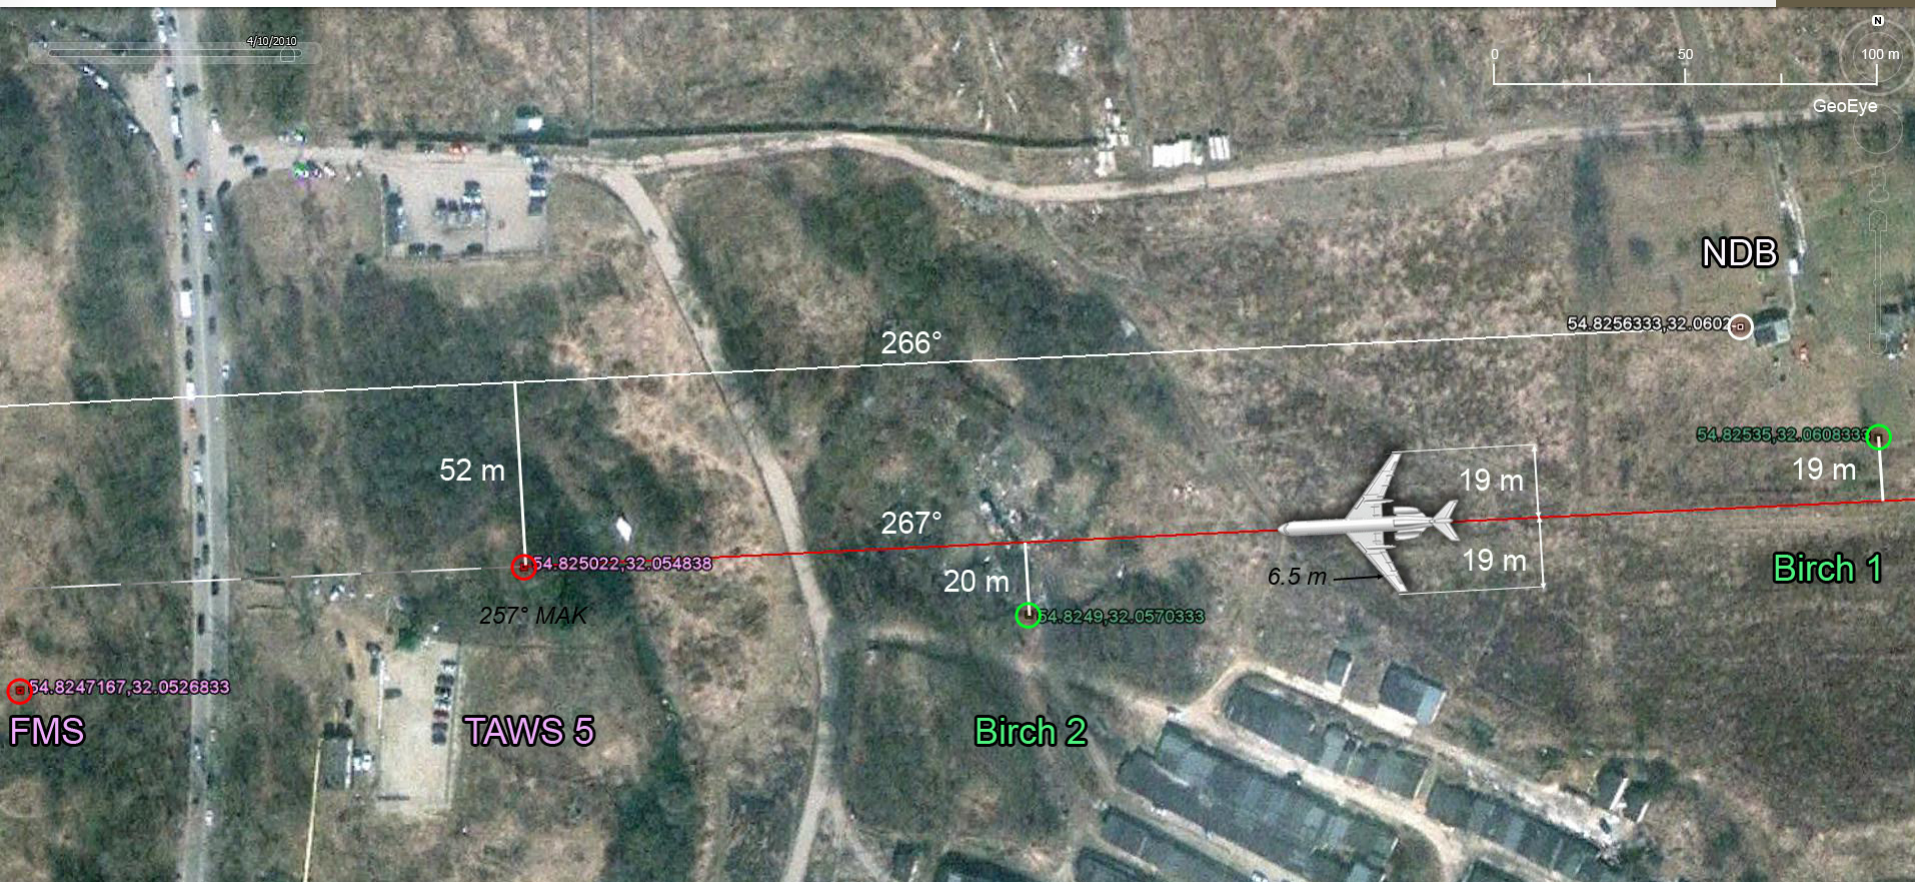
Horizontal Plane Trajectory Near the Birch Tree

According to TAWS #37 and #38 logs, the aircraft did not change its magnetic course 140 meters past the birch tree, which is inconsistent with information in both MAK and KBWL reports.

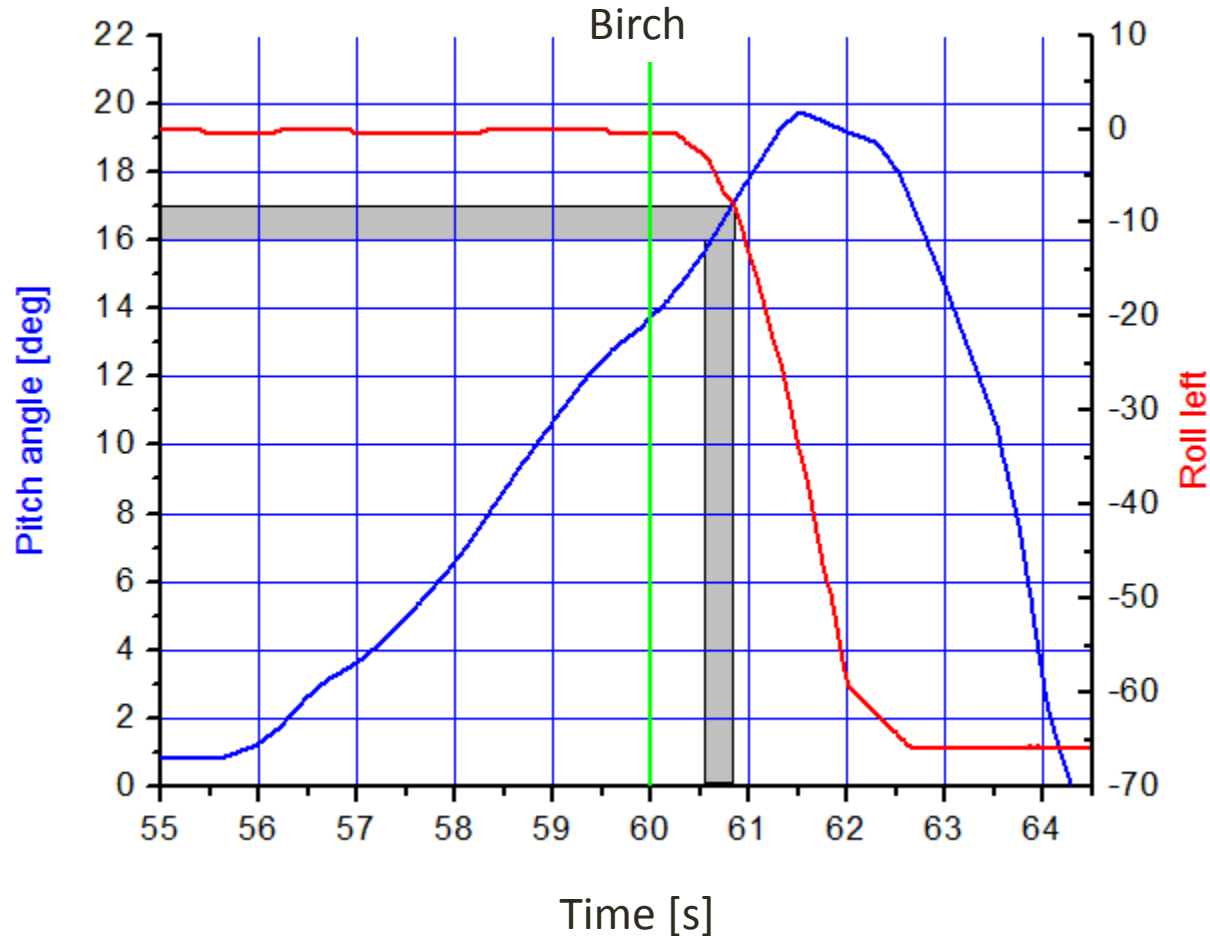
Pitch angle and Roll left parameters (MAK)

Taking into account the effects of the aircraft rolling to the left as well as losing a considerable amount of airfoil surface, we can conclude that the critical angle of attack would have been exceeded one second after left wing's impacting the birch tree.

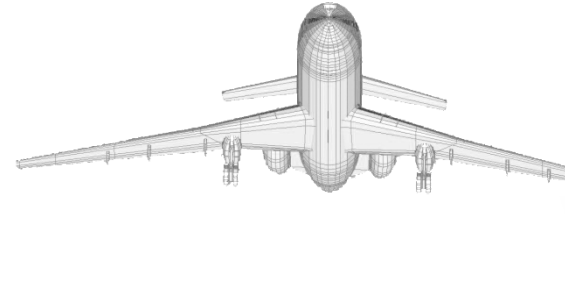
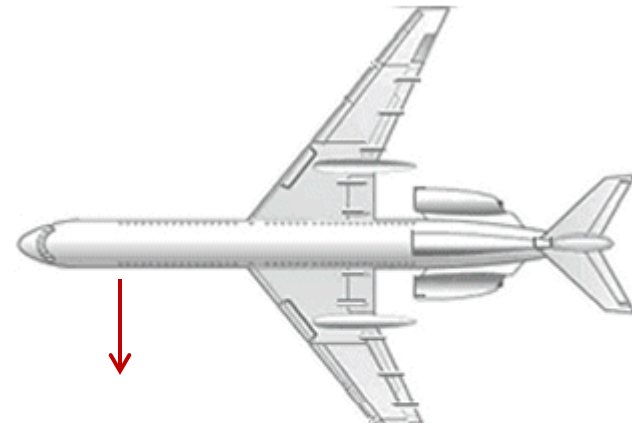
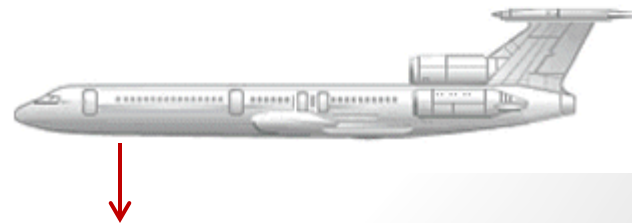
The left wing moves downwards with an initial acceleration of **-23.9**, which then decreases to **-2.5 deg/s²** because of drag induced by the rolling motion

The net effect is that the aircraft is being rolled to the left
(3.0 to 0.55 deg/s²)

The nose pitches down violently
(1.3 to 6.1 deg/s²)

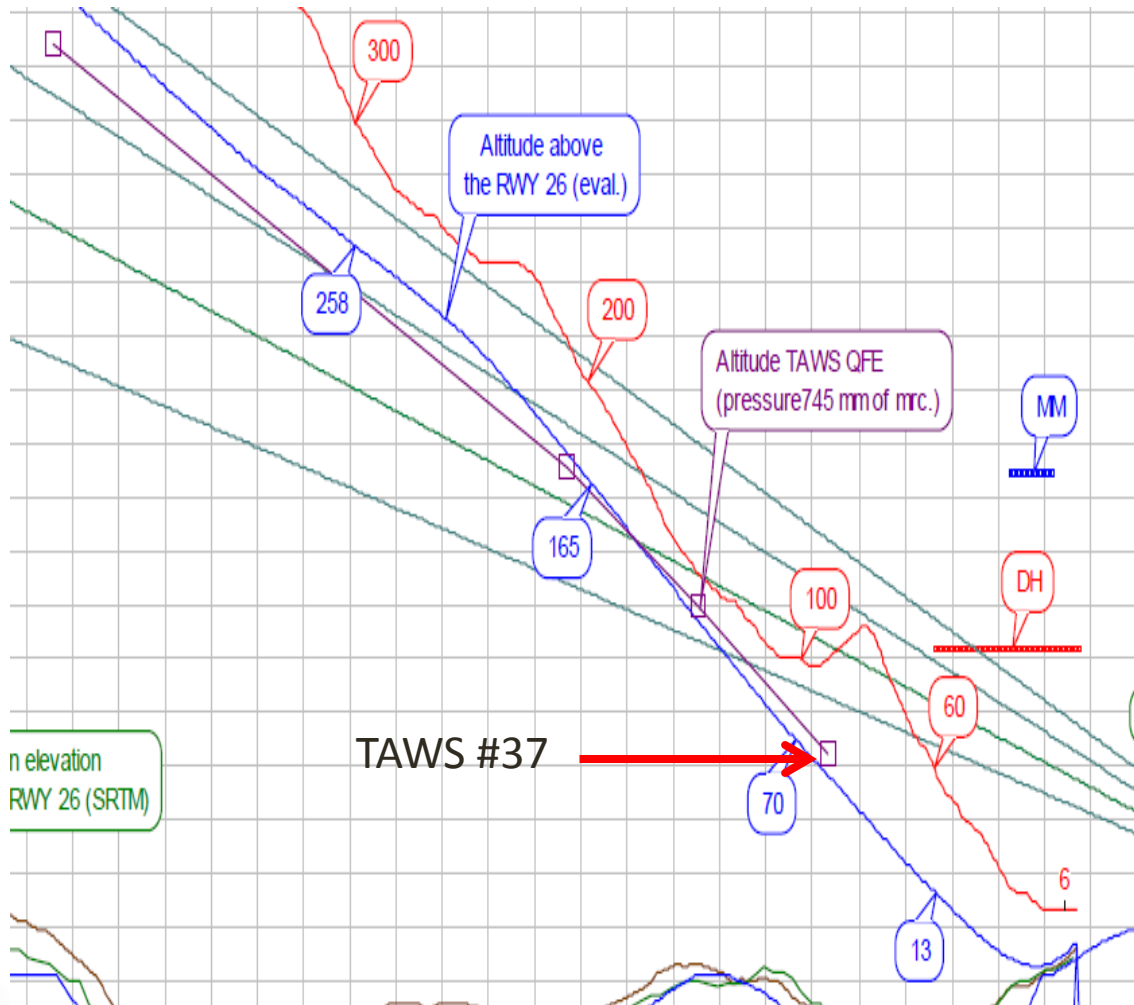
Fig. 46 of the MAK report, showing the aircraft's trajectory base on TAWS logs #34 through #37 (purple line) as well as a reconstruction of radio altitude (blue line).

The blue line does not contain any explicit information from TAWS #38 or any of the FMS logs. We do see that the blue and purple lines cross at one point. All TAWS and FMS logs were known to both MAK and KBWL very early into their investigations.

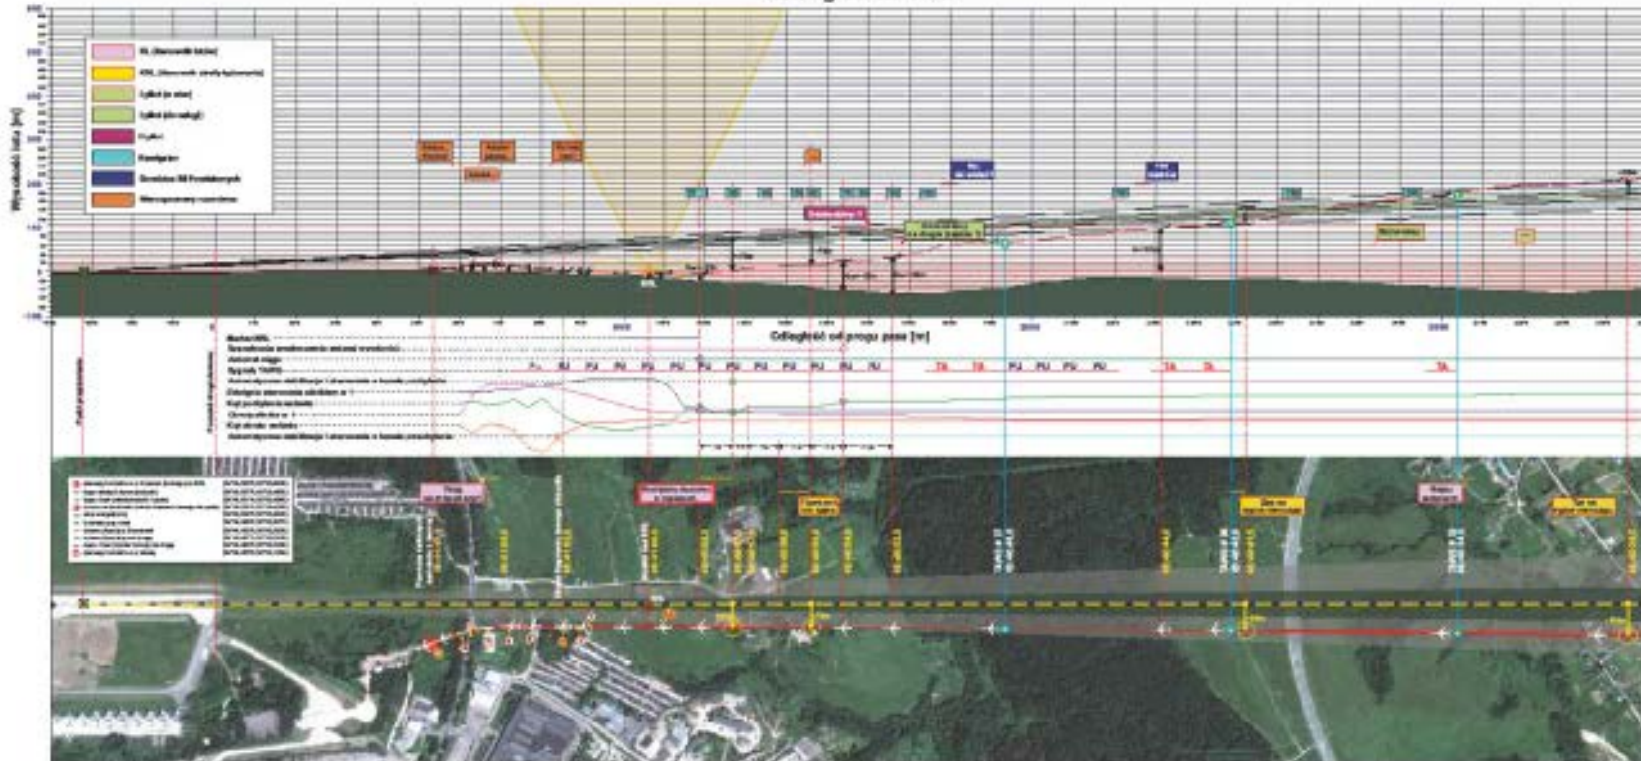
Załącznik nr 1.1

This slide shows the method used by KBWL to disguise the existence of this data. The fact of this disguise suggests that KBWL is fully aware of the fact that this data is inconsistent with their final conclusions.

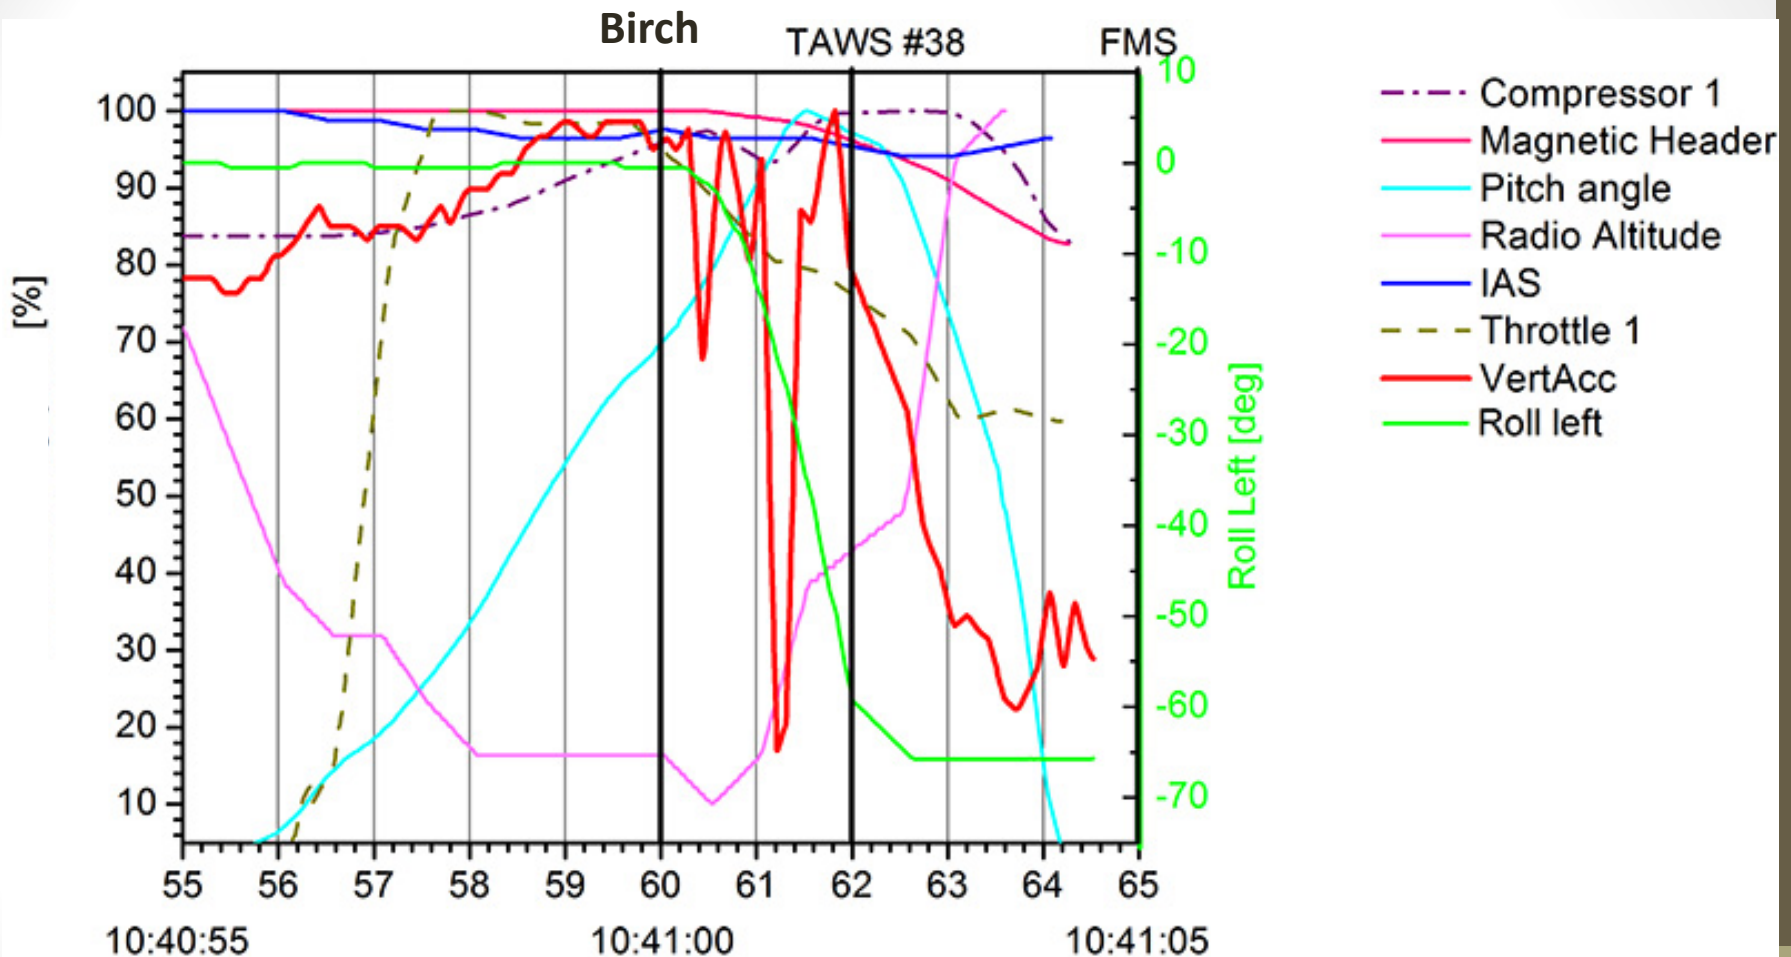
MAK Report, FDR Parameters (Fig. 25 and 45, English Version)

Two sudden dips in the graph of vertical acceleration (red line) appear in graphs of both MAK and KBWL reports. Neither report mentions them in the analysis.

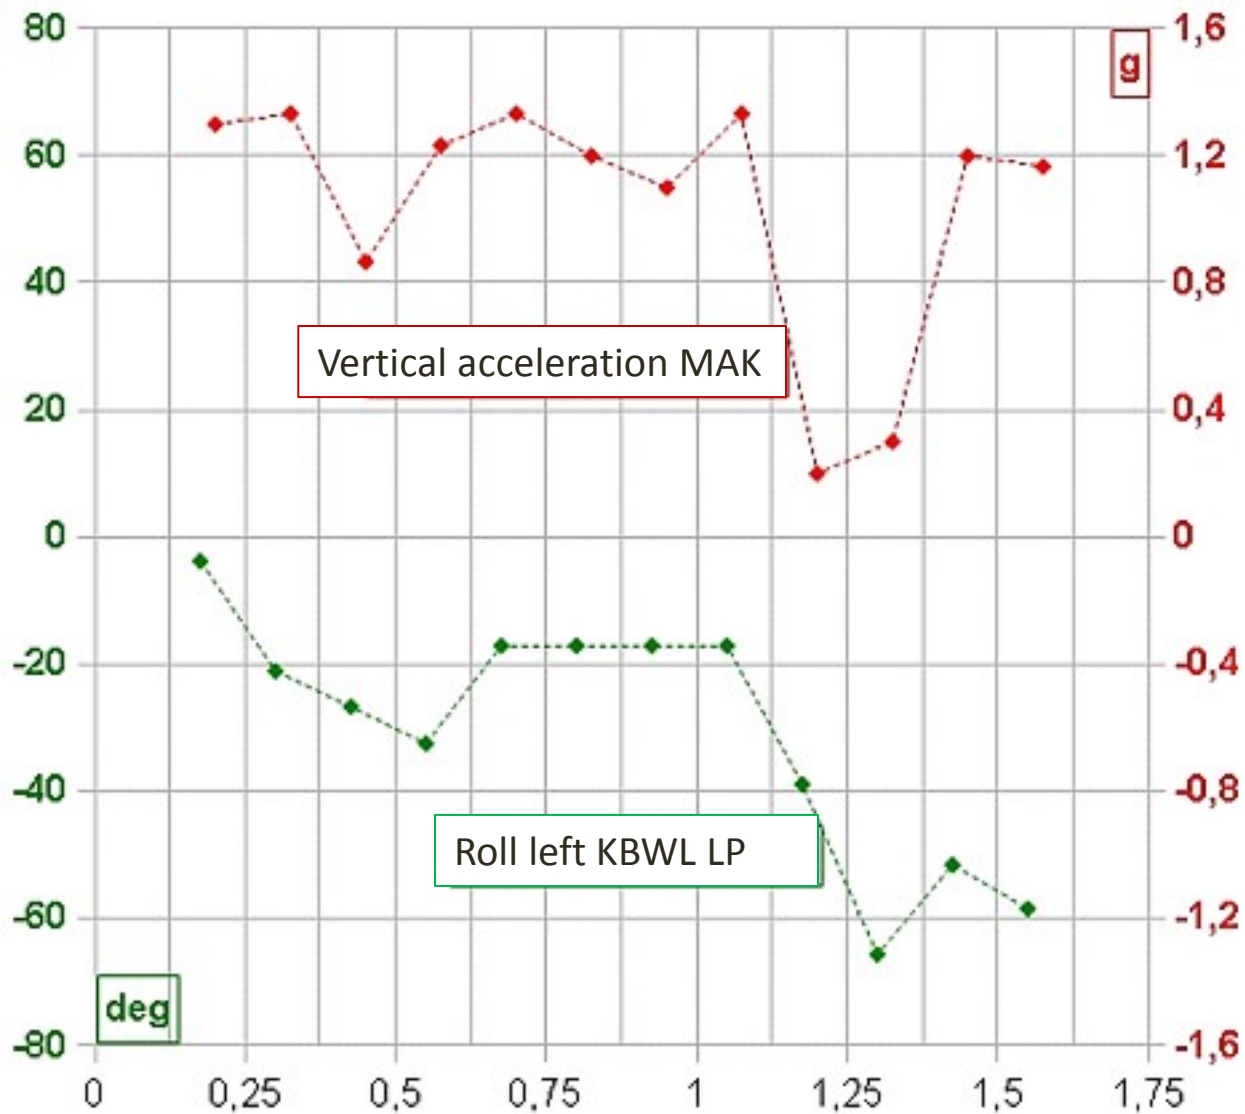
Time correlation between peaks of vertical acceleration (MAK) and roll left KBWL

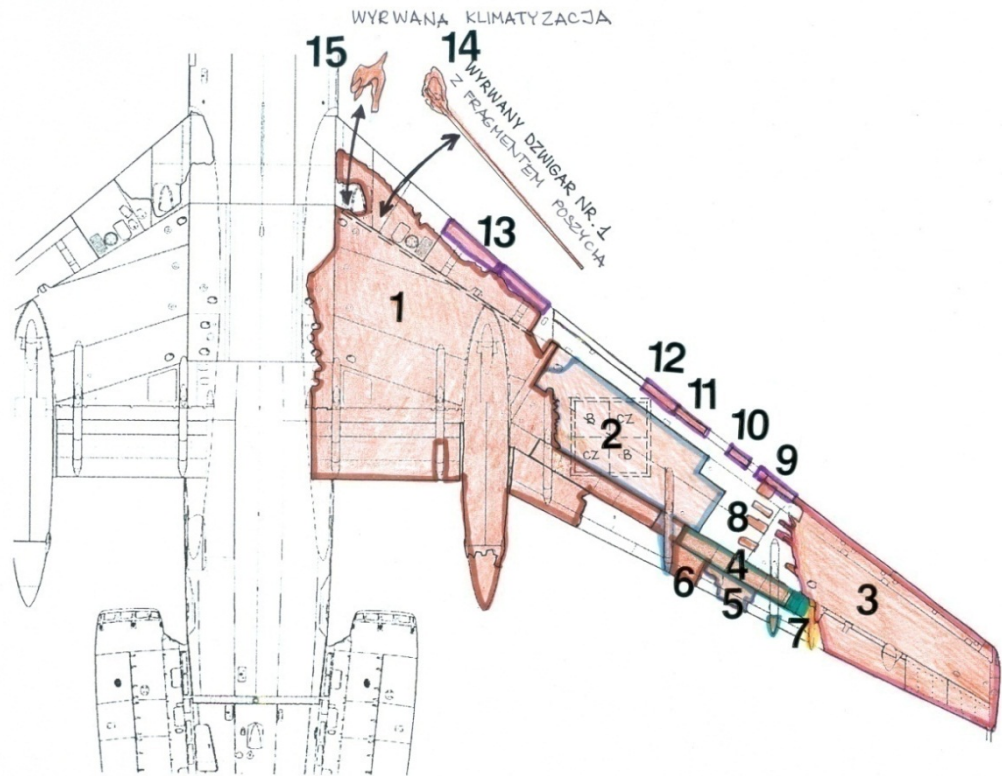
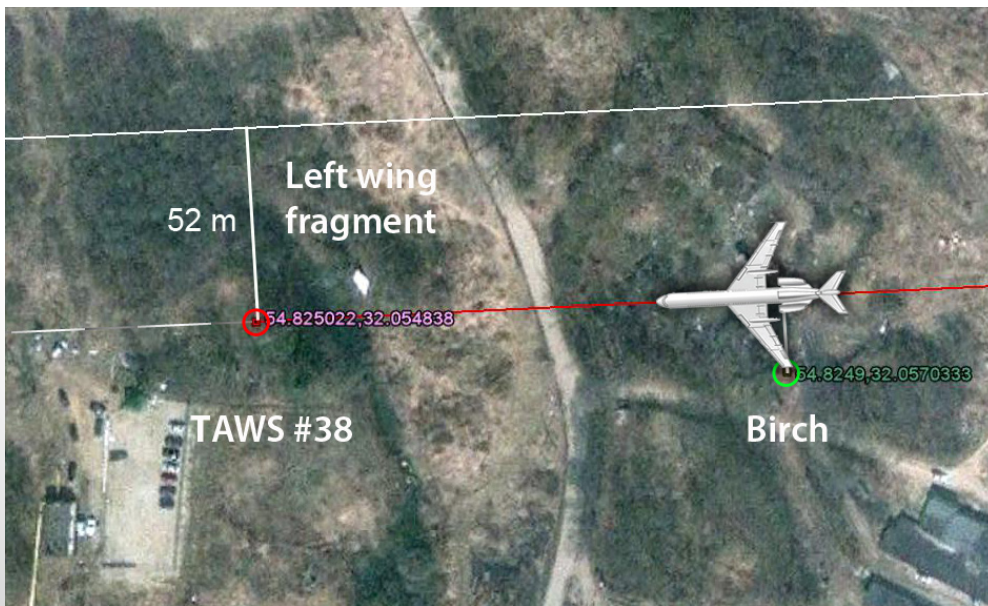
The left wing, view from the bottom. The parts are pieced together based on images from the day of the incident.

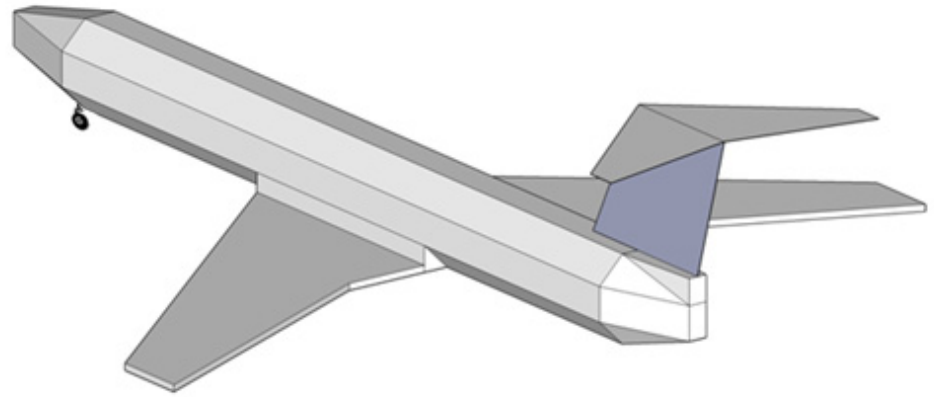
Phase I

Internal or external explosion in front of the left wing

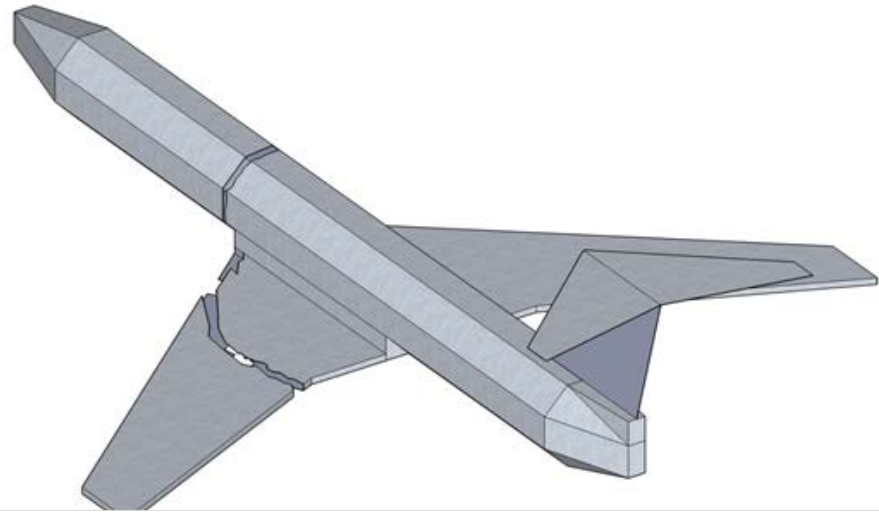
Phase II

Internal explosion in central position in airframe

The loss of the wing's leading edge near the fuselage and the entire left-most part of the wing had two aerodynamic effects: loss of lift on the left side and increase of drag. The first effect induces roll to the left, while the second one induces a change in magnetic heading.

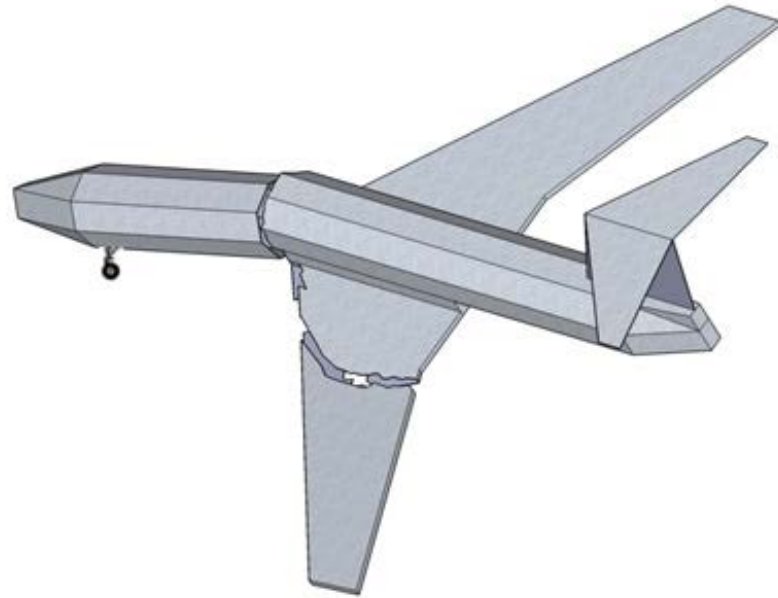
Phase III

The rear part of the airframe with wings and vertical stabilizer rolls to the left independently of the front part which stays in its natural position

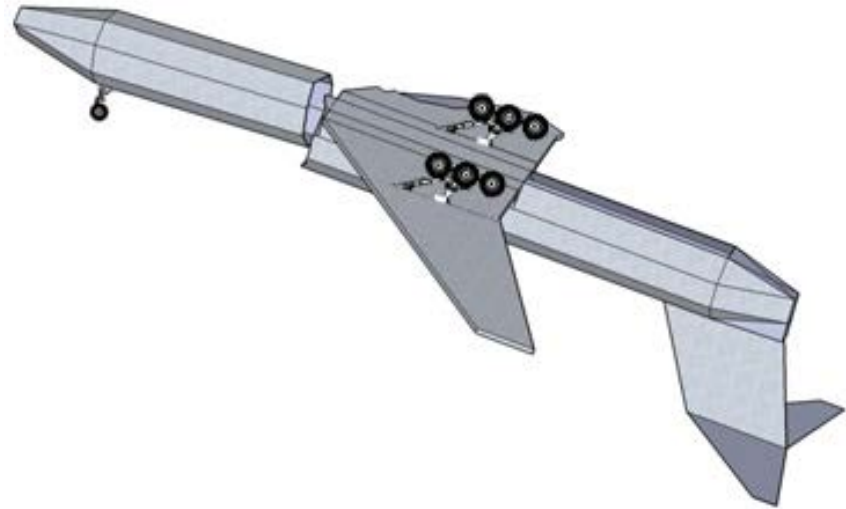
Phase IV

Impact with the ground: only the rear part of the fuselage is inverted.

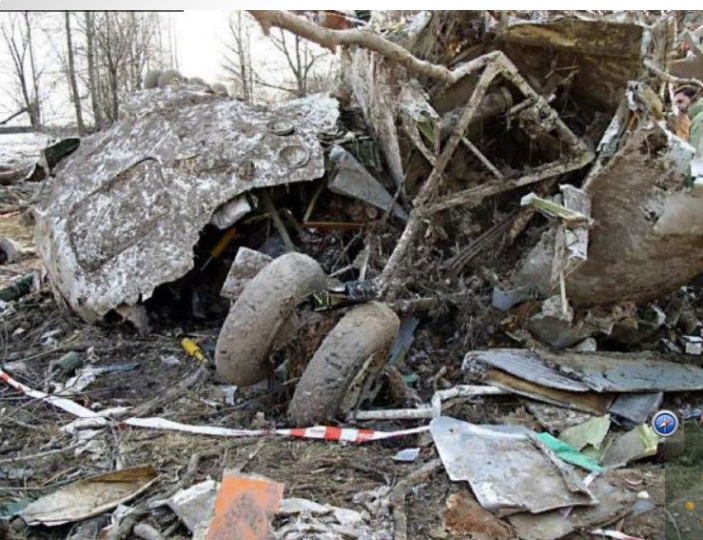
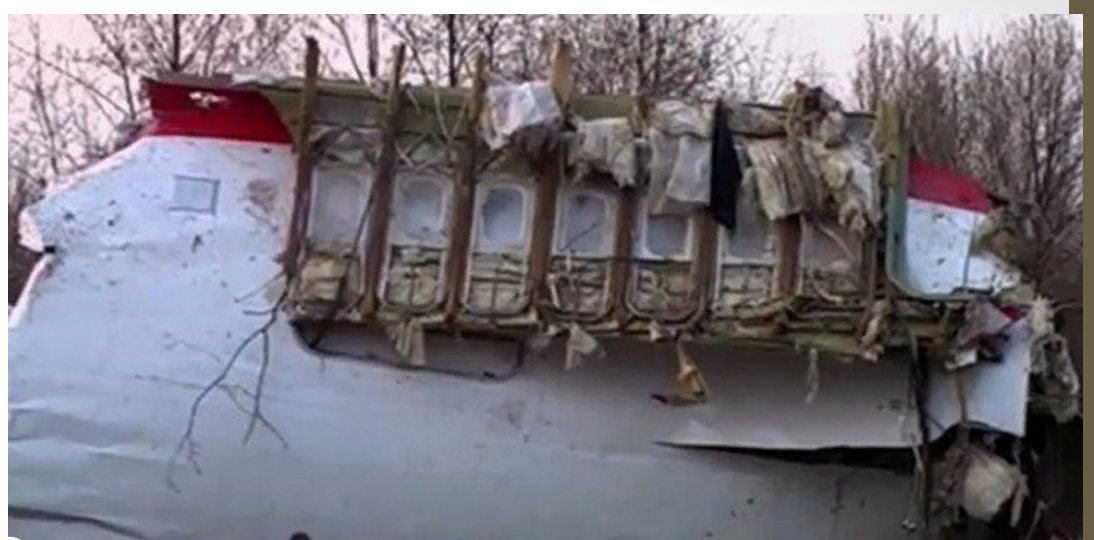
Angular momentum about the roll axis breaks the fuselage apart completely, separating the front of the fuselage from the rear, with the rear continuing to roll to the left.

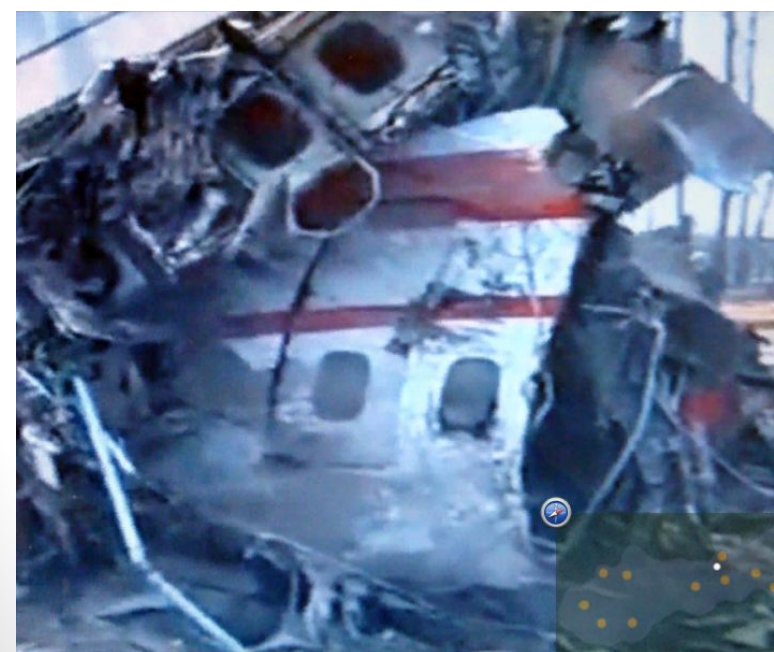
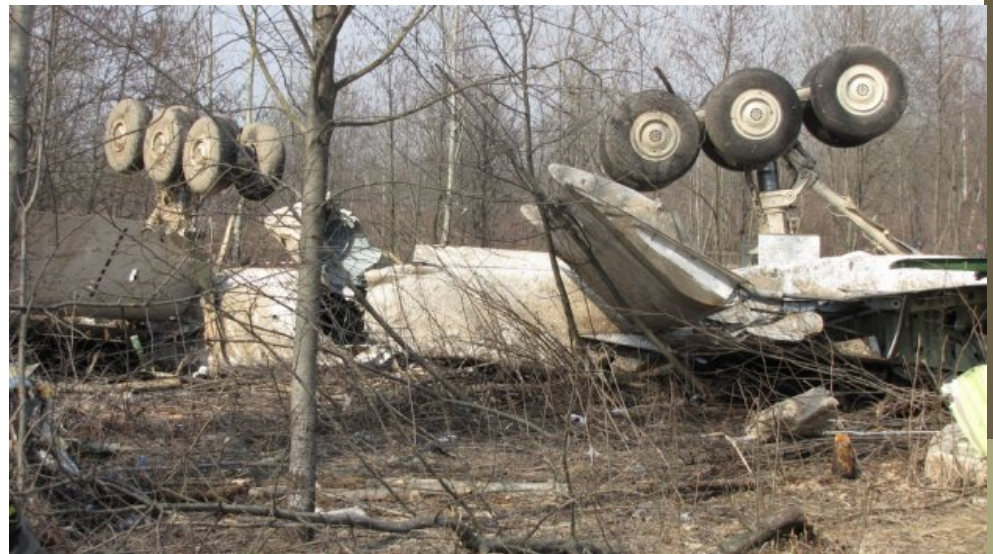
Cokpit and front part of fuselage are not inverted

Rear parts of the fuselage in inverted position
