Remarks
Of the Republic of Poland
as:
the state of registration and operator

on the draft Final Report
regarding
the investigation into the accident of the Tu-154M tail number 101 aircraft
which occurred on 10 April 2010
drafted by
the Interstate Aviation Committee (IAC)

Warsaw, 19 December 2010

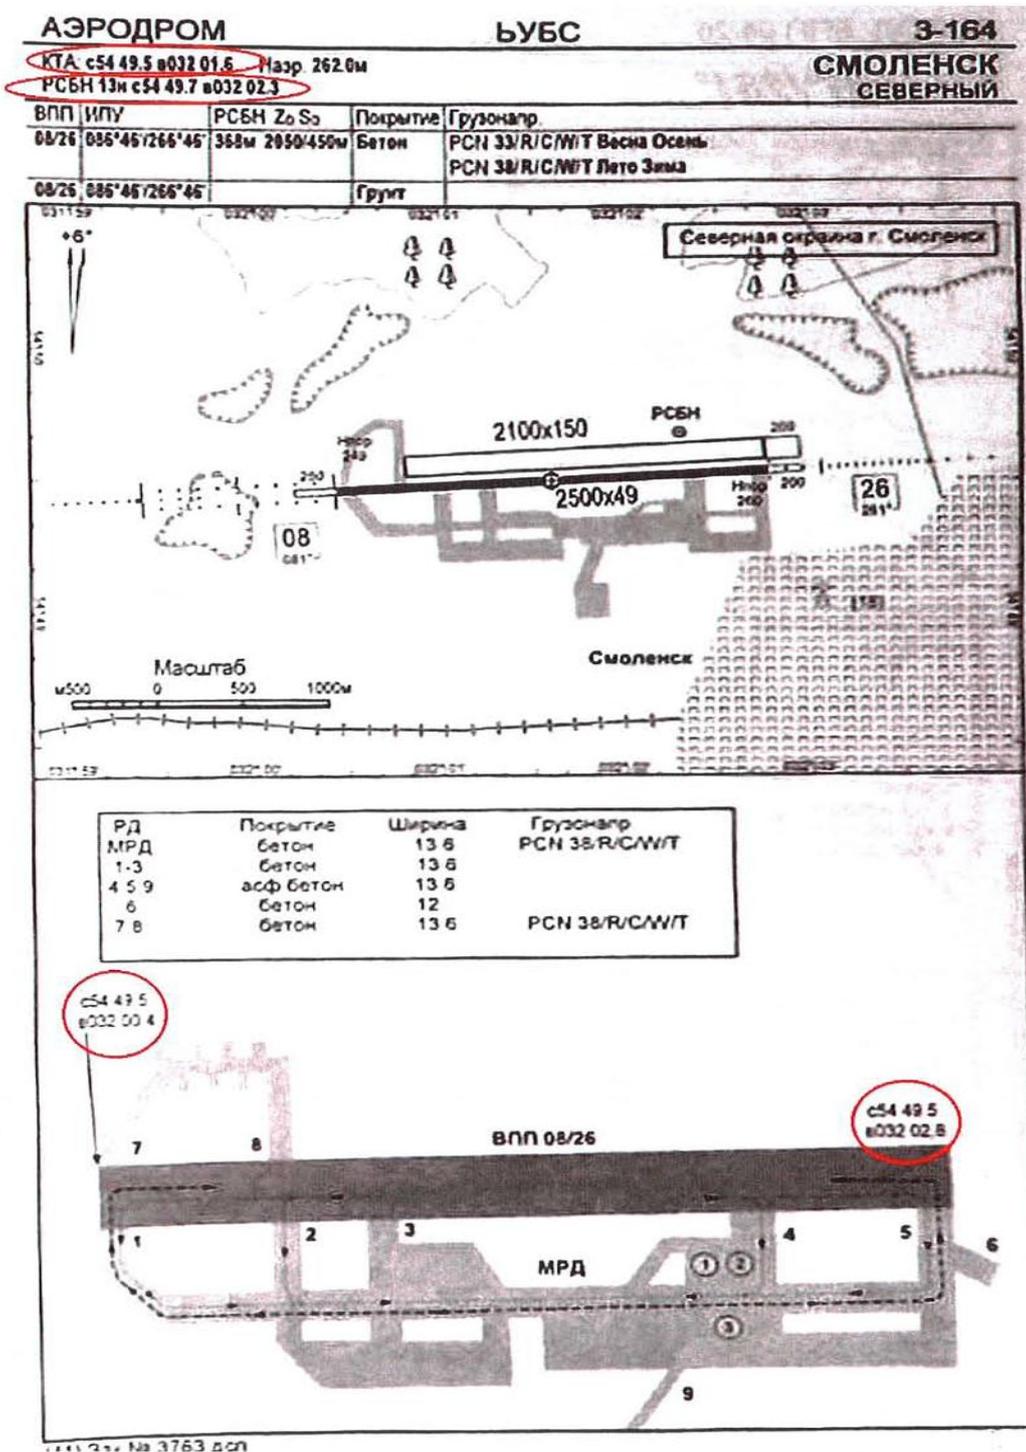
Smolensk "Severny" aerodrome diagram provided to the Polish side in 2009, indicating the geographical coordinates of runway thresholds and the ARP (without indicating reference system)

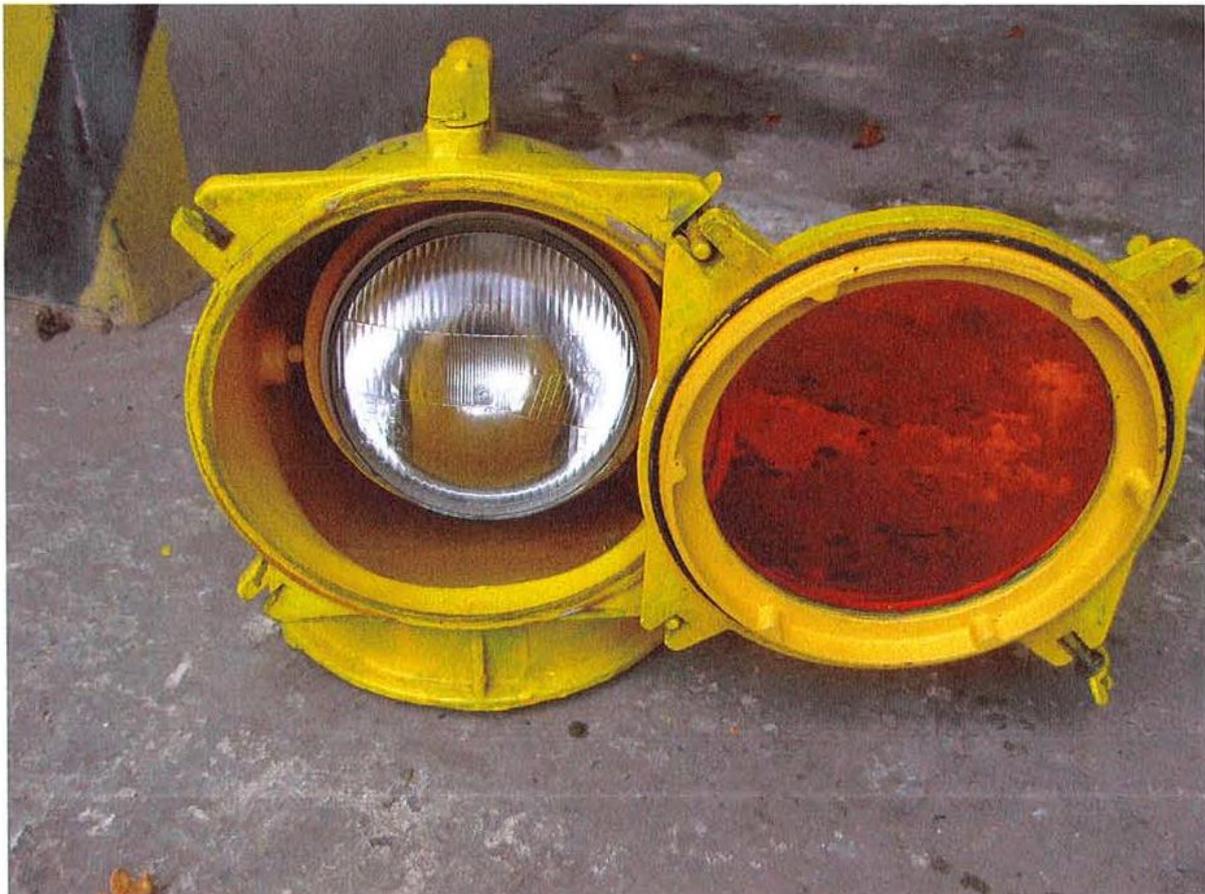
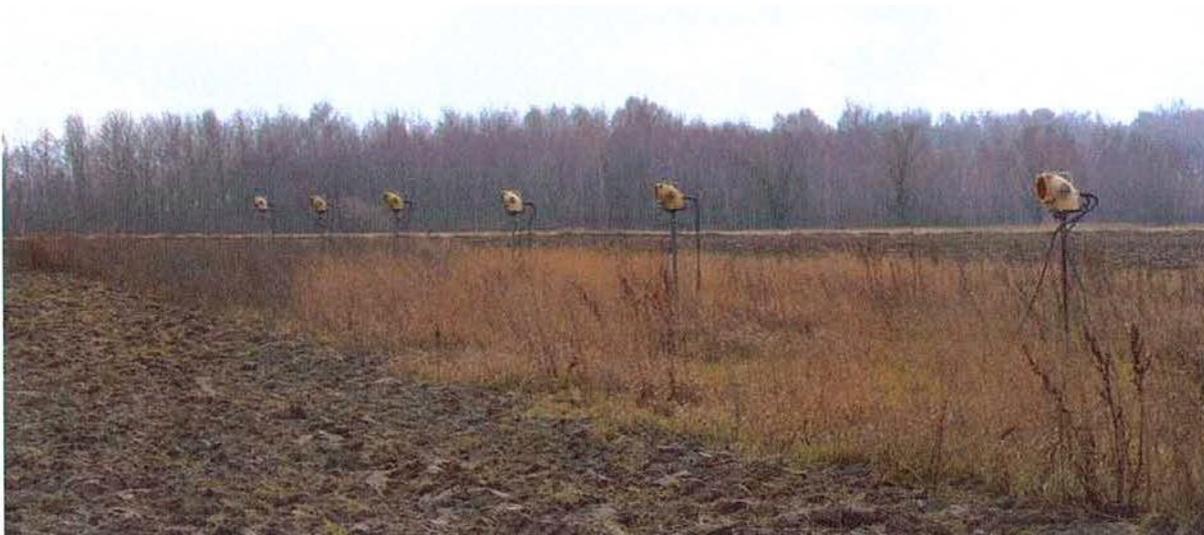
This is what the elements of the LUCH-2MU lighting system should look like – the below pictures

Do not come from Smolensk “Severnoy” aerodrome

The above photographic documentation shows, that the lighting elements of the lighting system of the Smolensk “Severny” aerodrome originated from an unspecified device, did not have mirrors and focusing lenses, and did not possess a vertical and horizontal plane lighting angle adjustment function.

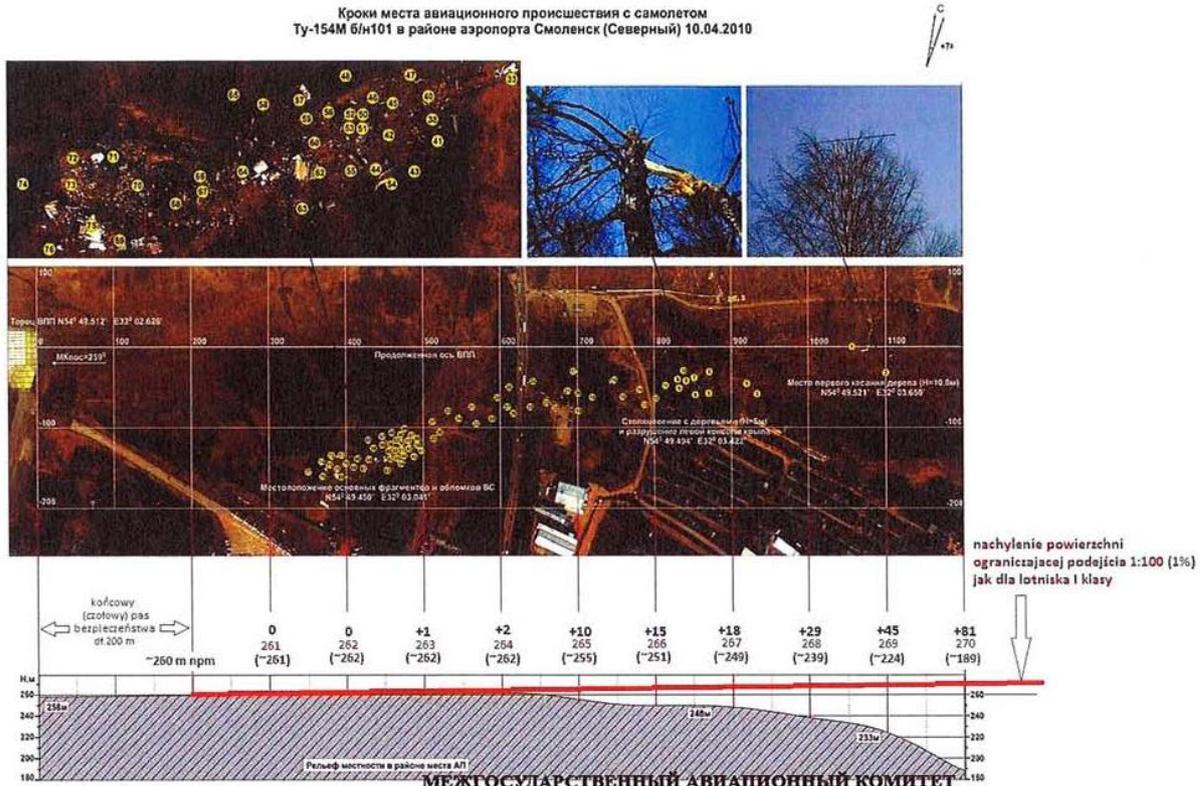
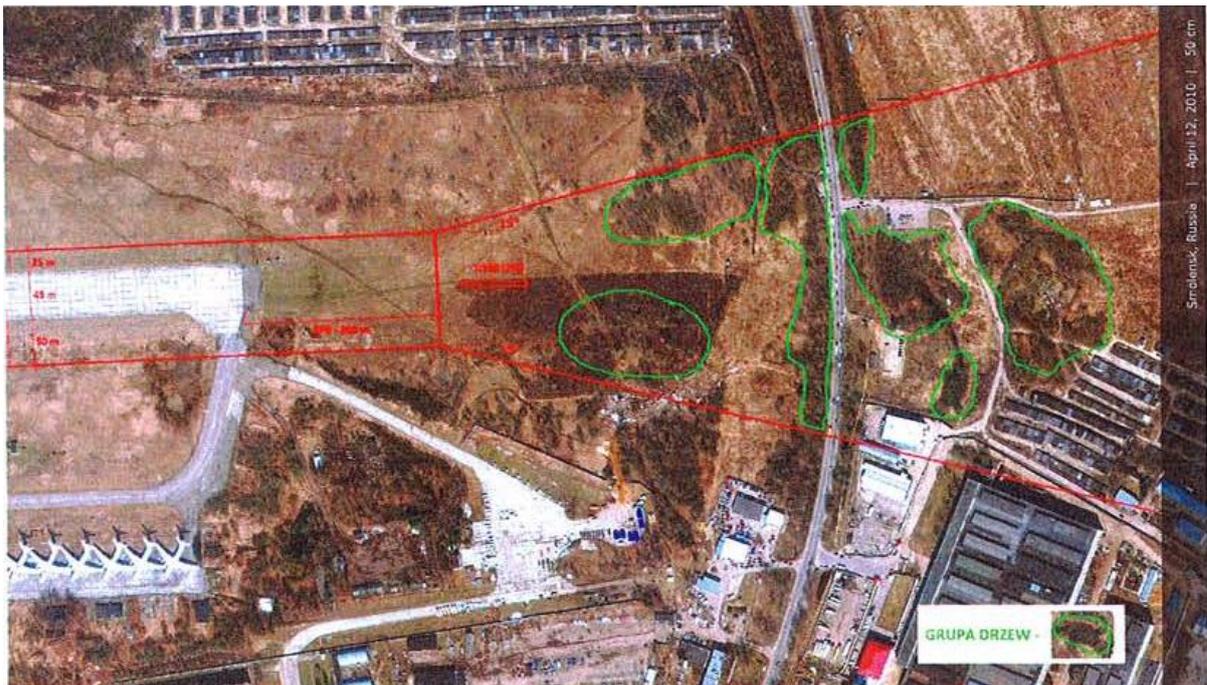
- surface stretching from the end of the Final (lead) Safety Strip (KPB), i.e. 200 m from the 26 threshold;
- width of the initial (internal) margin 124 m;

- separation of side margins 15°;
- slope 1:100 (1%);
- initial ordinate 260 m above sea level (due to the elevation of the surface of the KPB relative to the 26 threshold).

tilt angle for approach limiting surface 1:100 (1%) as for class I aerodrome;-
 +26 permissible building height above ground level
 274 absolute height above sea level of approach surface
 (~ 248) ground ordinate above sea level

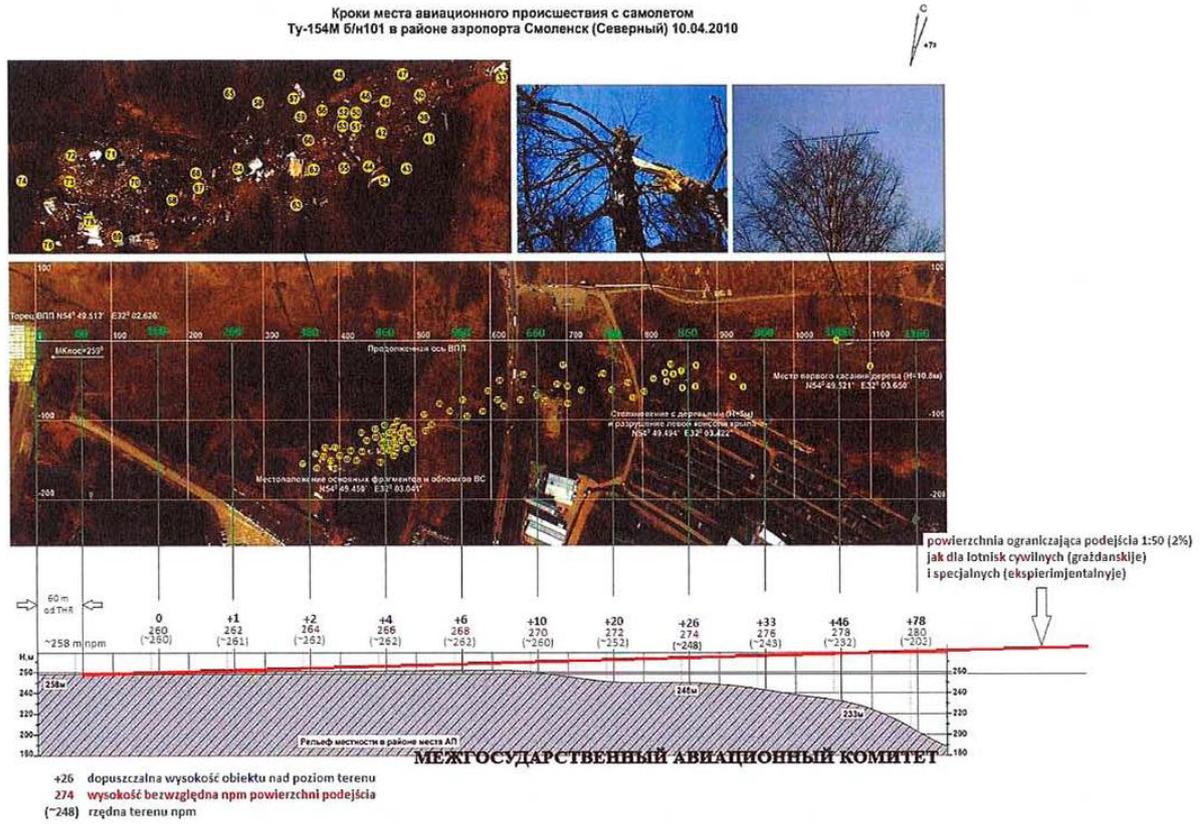
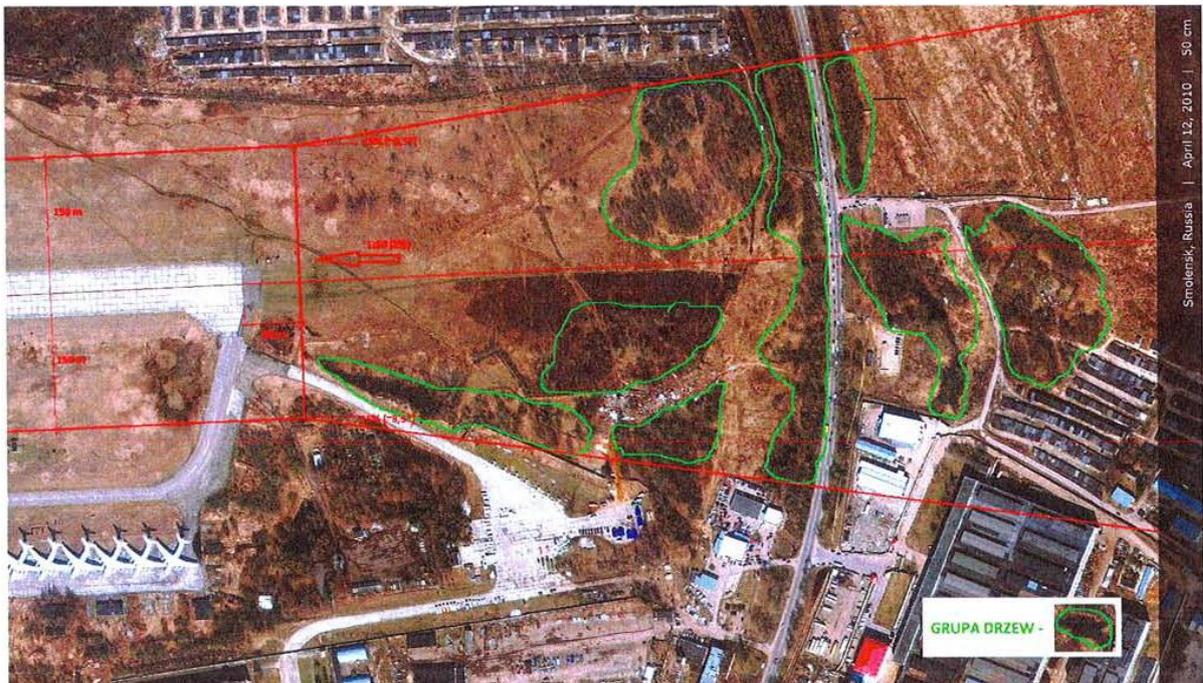
OPTION II

- surface stretching 60 m from the 26 threshold;
- width of initial (internal) margin 300 m (150 m from the DS axis);
- separation of side margins 15% (app. 8.5°);
- slope 1:50 (2%);
- initial ordinate 258 m above sea level (height of 26 threshold).

approaches 1:50 (2%) for civil aerodromes

- + 26 permissible building height above ground level
- 274 absolute height above sea level of approach surface
- (-248) ground ordinate above sea level

An analysis of the approach surface calculated in line with above initial parameters shows that:
