MAK and KBWL LP Reports Data Analysis

Kazimierz Nowaczyk, Ph.D.
Assistant Professor
University of Maryland

MAK – Interstate Aviation Committee
KBWL LP - Polish Air Incident Investigation Committee

SOME TECHNICAL AND STRUCTURAL ASPECTS
OF THE SMOLENSK PLANE CRASH

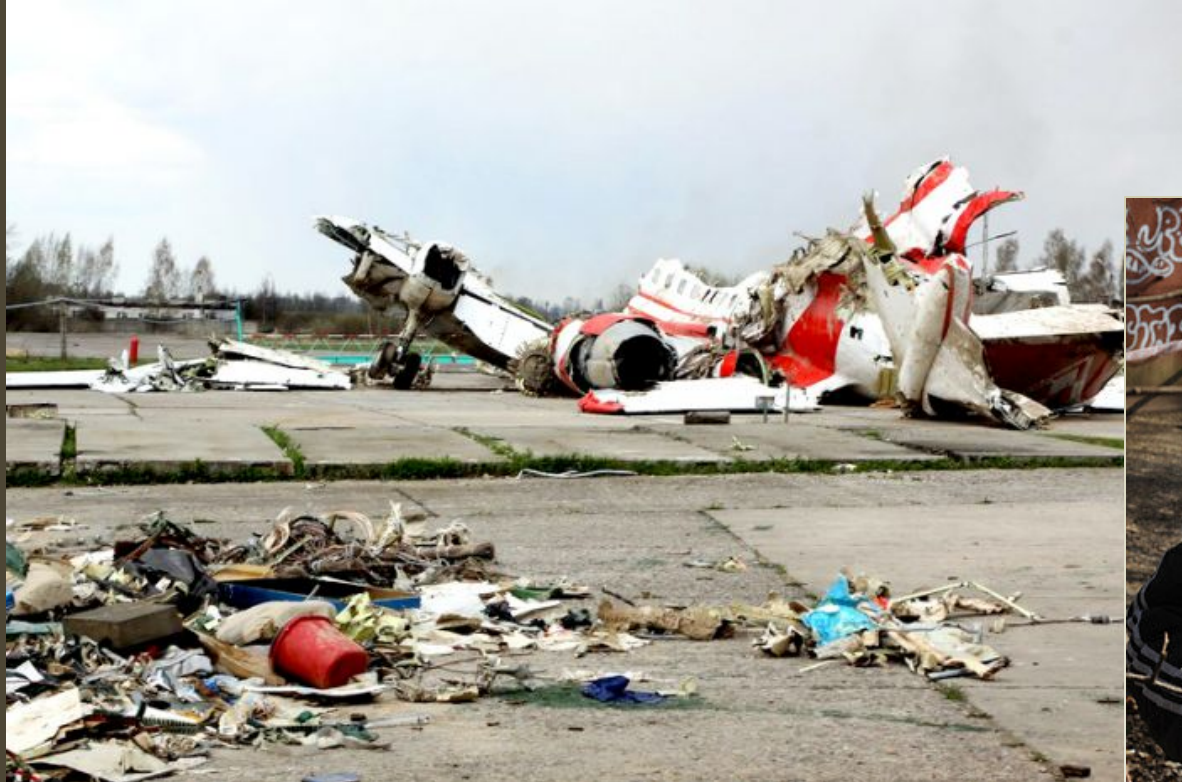
Properly secured air crash investigation site?

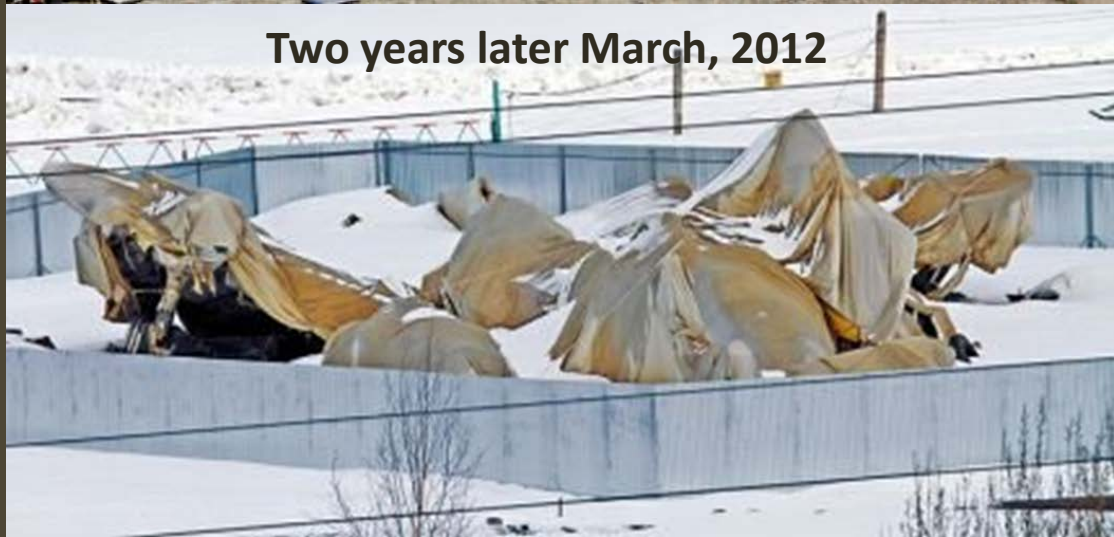
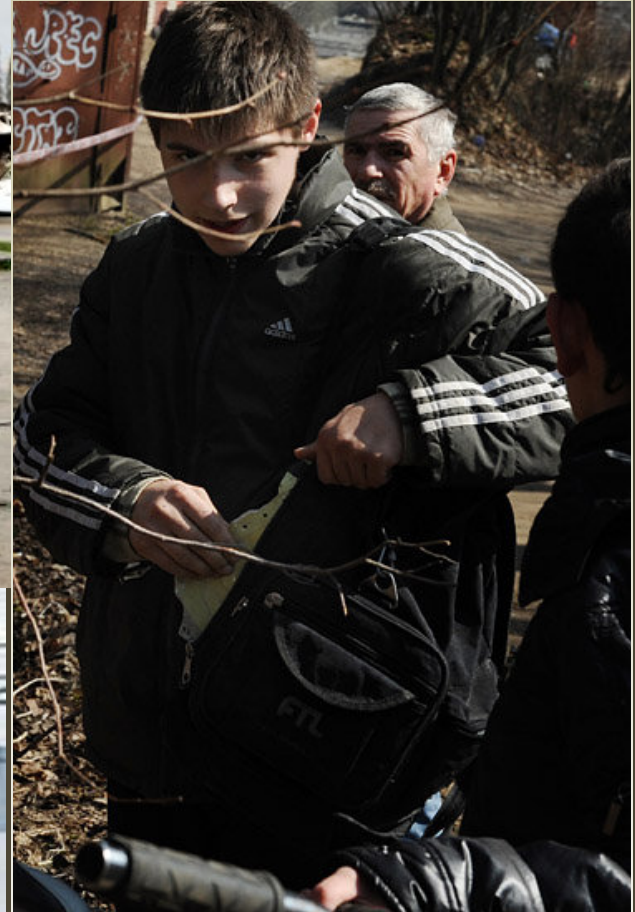
Two years later March, 2012

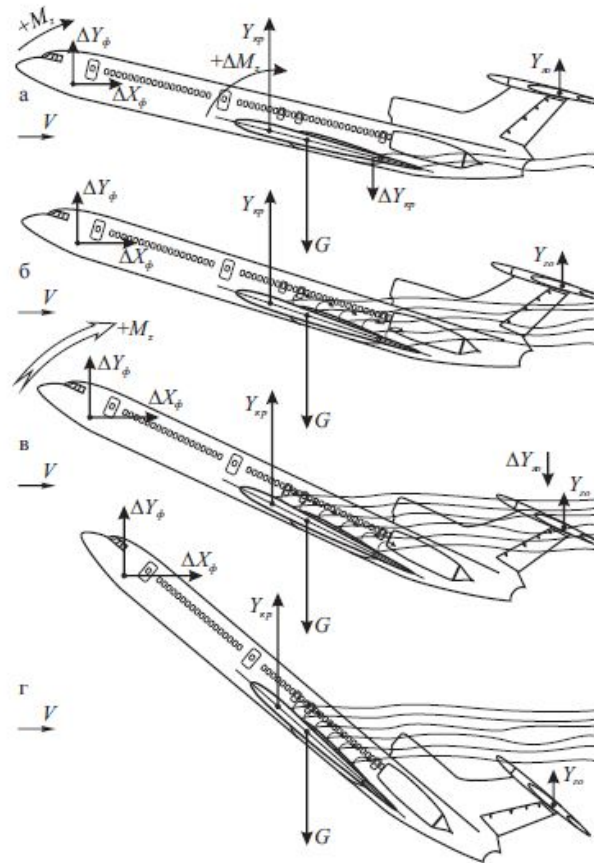
Critical flight phases of a Tu-154M aircraft in cruising configuration¹

Рис. 7.24. Развитие срыва на стреловидном крыле у самолета с верхним расположением горизонтального оперения:

а - $\alpha = 15 \dots 17^\circ$ - начало срыва у концов стреловидного крыла, падает устойчивость по перегрузке; б - $\alpha = 18 \dots 22^\circ$ - распространение срыва по всему крылу; в - $\alpha = 22 \dots 35^\circ$ - неустойчивый режим глубокого срыва; г - $\alpha = 40 \dots 45^\circ$ - оперение выходит из мутной струи и попадает в невозмущенный поток; самолет балансируется на неустойчивом режиме глубокого срыва

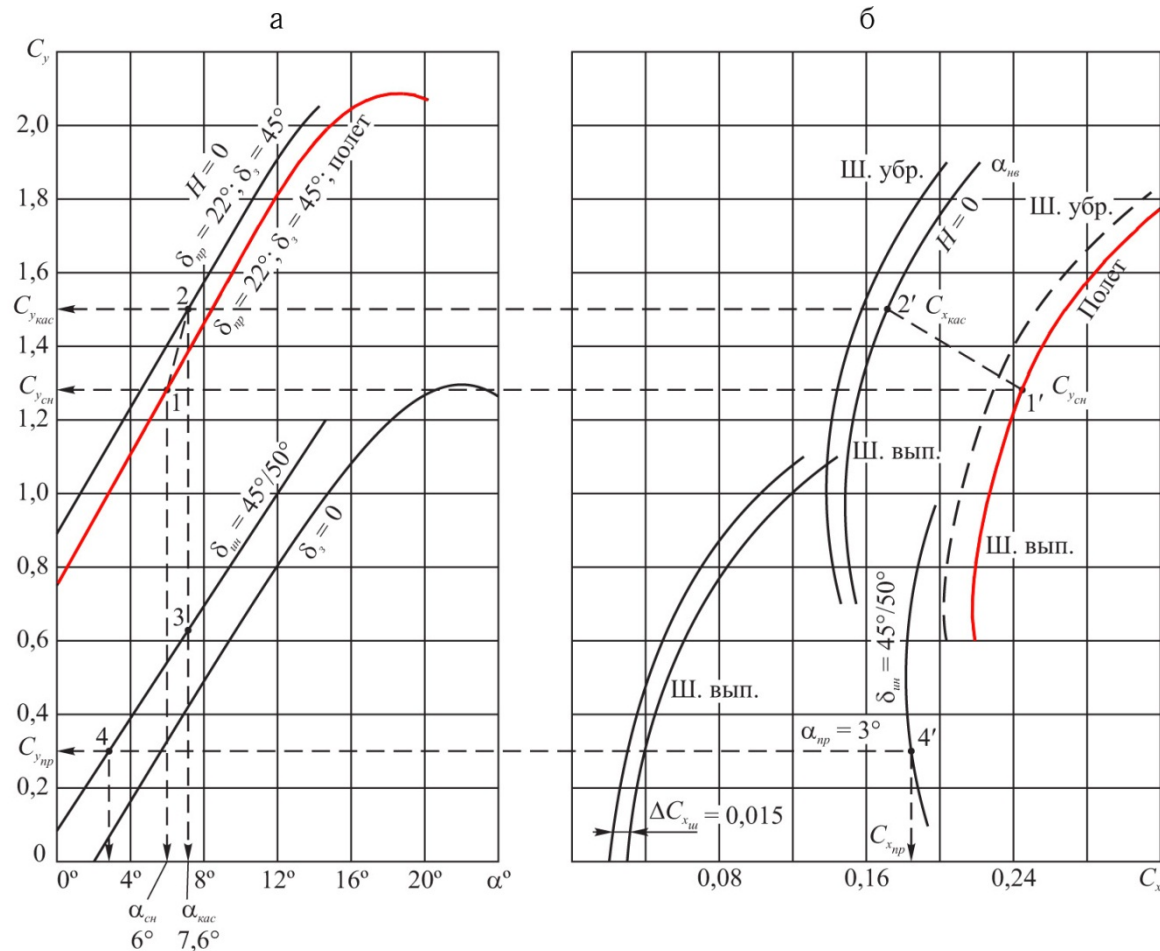
Lift coefficient (C_y), and drag coefficient (C_x) of a TU-154M aircraft in landing configuration¹

Рис. 6.5. Аэродинамические характеристики самолета Ту-154М при снижении и посадке:
 а - $C_y = f(\alpha)$; б - $C_y = f(C_x)$; — с влиянием земли; - - - без влияния земли

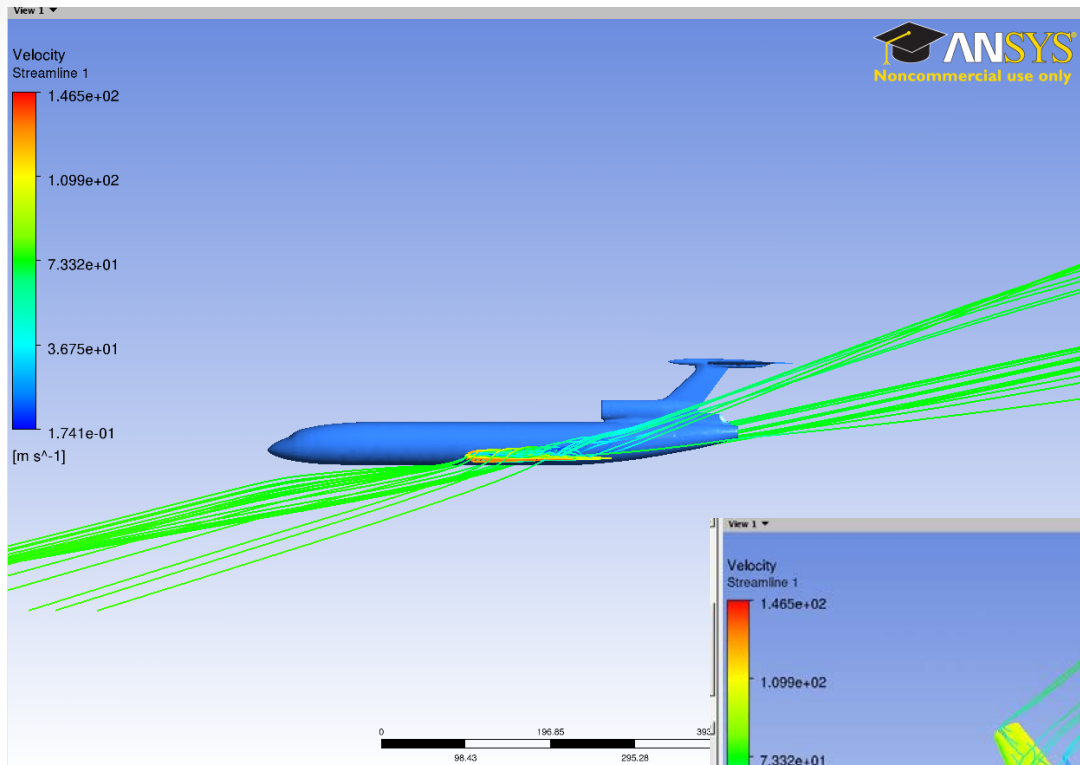
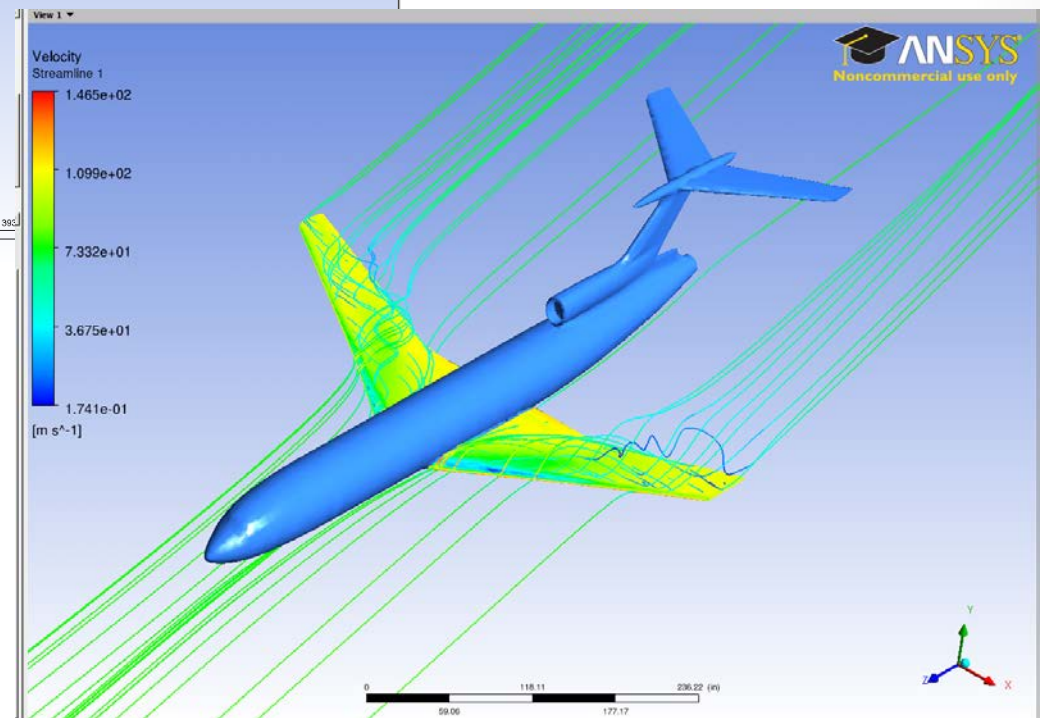
Airflow vectors

The behavior of the aircraft after losing part of the wing has also been analyzed by a team of researchers lead by prof. Brawn of the University of Akron.

As the aircraft loses part of its left wing, drag works to counteract roll with the force equivalent to air moving at 5 meters per second, applied to the top of the right wing and to the bottom of the left wing.

The left wing moves downwards with an initial acceleration of **-23.9**, which then decreases to **-2.5 deg/s²** because of drag induced by the rolling motion

The net effect is that the aircraft is being rolled to the left
(3.0 to 0.55 deg/s²)

The nose pitches down violently
(1.3 to 6.1 deg/s²)

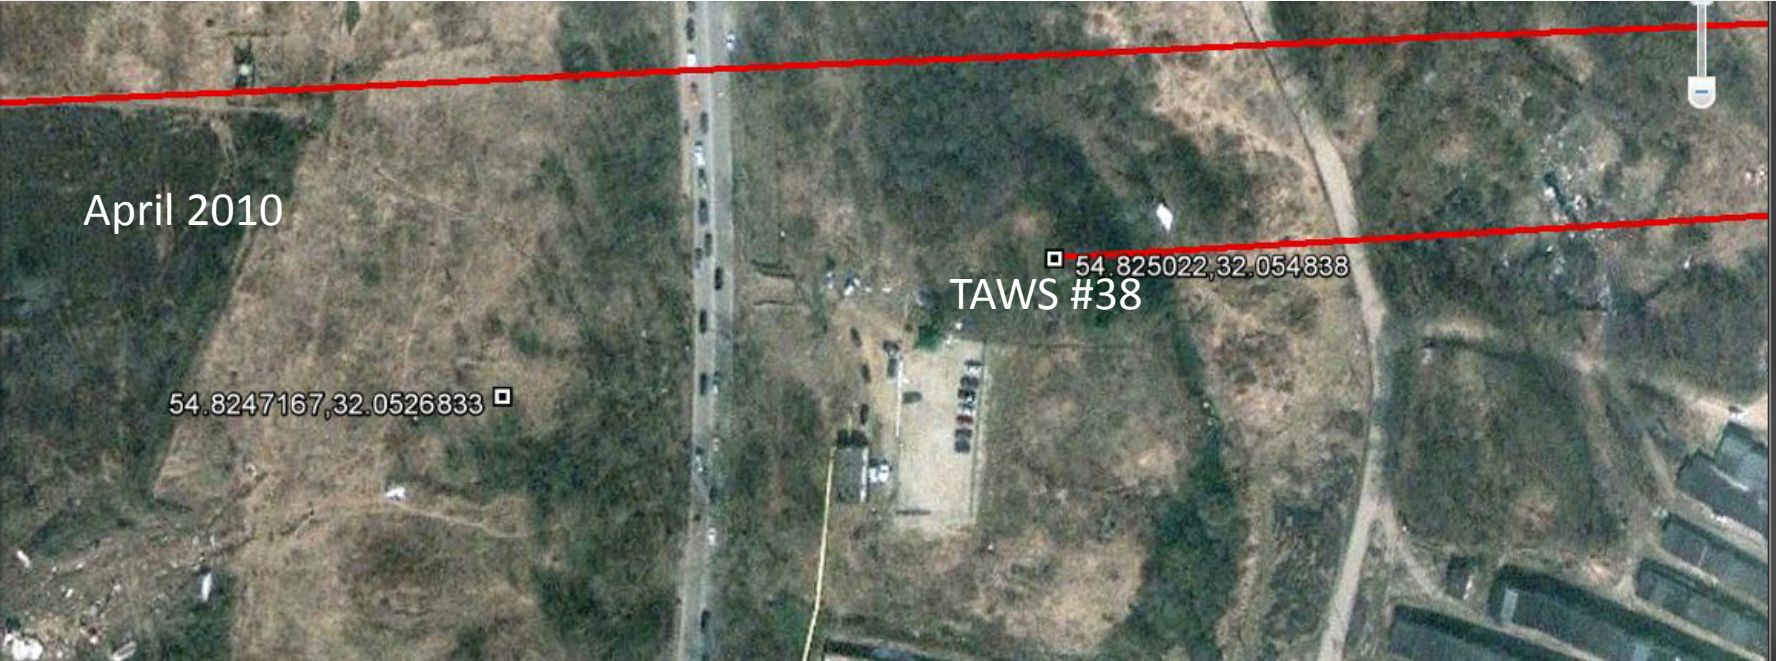
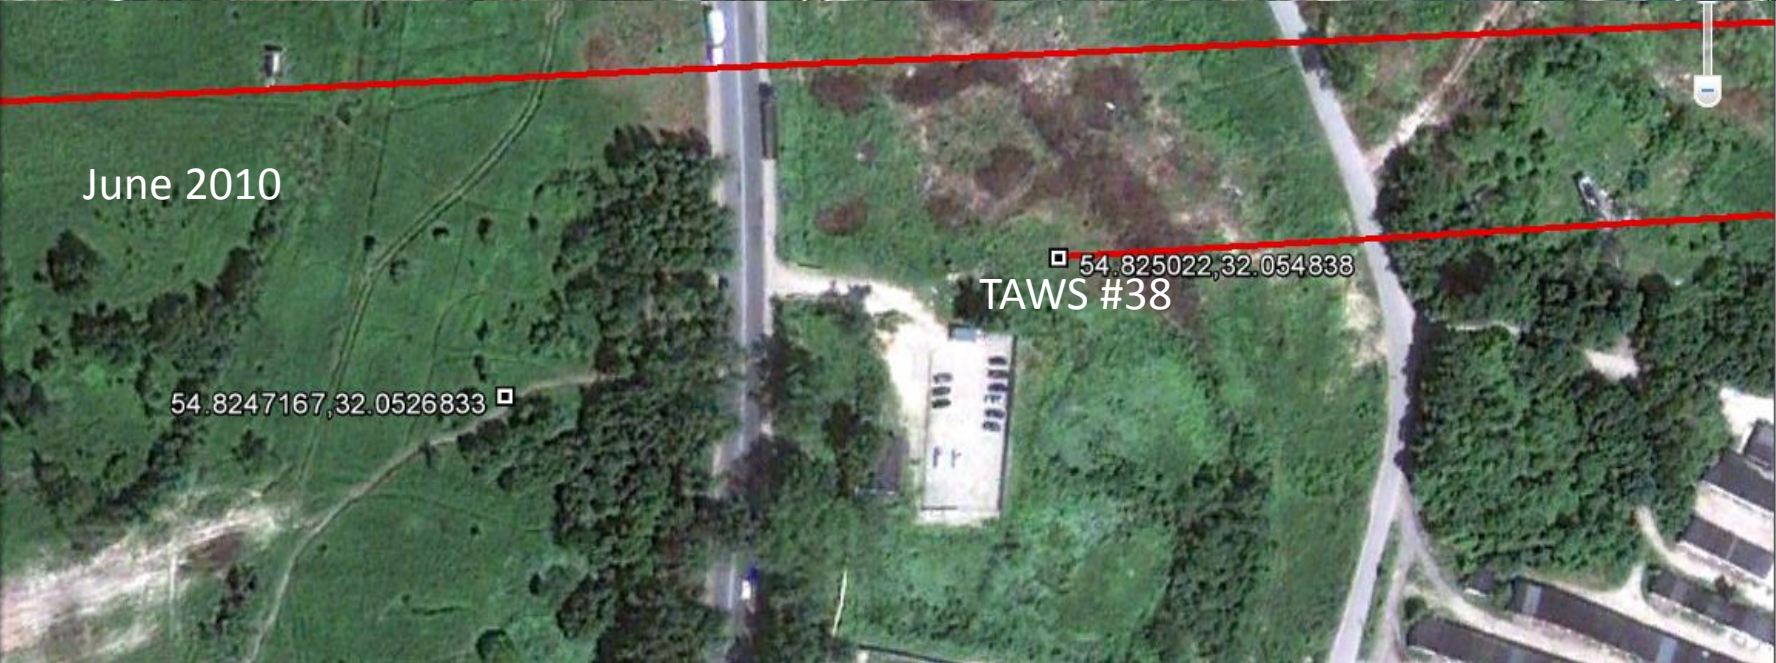
Satellite Images of the Area Where the Last TAWS Event Has Occurred (April and June 2010)
